THE CADILLAC SERVICEMAN

PUBLISHED BY
CADILLAC MOTOR CAR DIVISION
DETROIT, MICHIGAN

DECEMBER
1960

VOLUME XXXIV No. 12
©1960 GENERAL
MOTORS CORPORATION

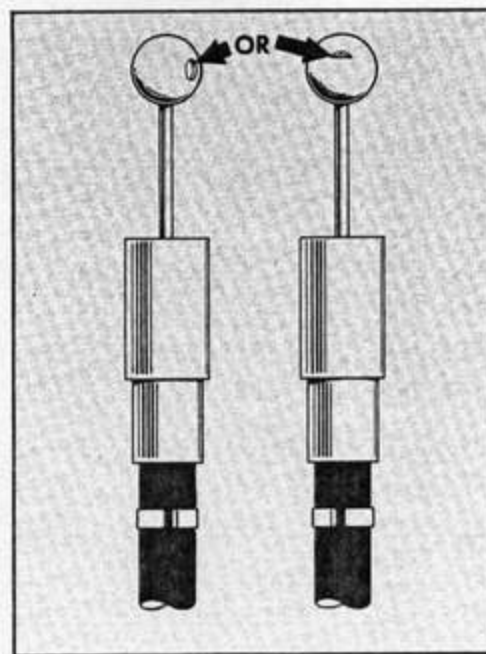
Fig. 1

SOME cases of erratic cruise control selector action may be encountered on early 1961 cars. This condition can be caused by the cable wire binding in the housing due to the tendency of early cables to twist into a spiral.

isolated cases may arise where the difficulty is caused by some component of the control assembly itself. This is especially true of cases where the control lever binds at the high or low limit of its movement.

If this condition is encountered on cars before approximate Engine No. 002000, an improved service cable, Part No. 1474873, (1476569-75 Style and Commercial Chassis), should be installed. The wire in the new cable does not have spiraling tendencies and is Teflon coated. The new cable can be easily identified by a depression in the ball at the end of the cable; see Fig. 1. Early cables had no markings in this area. All 1961 cars after approximate Engine No. 002000 have the late type cables.

Since there are several places where an interference can occur within the assembly, each component should be checked as outlined below when the assembly is removed, and the conditions corrected where necessary.

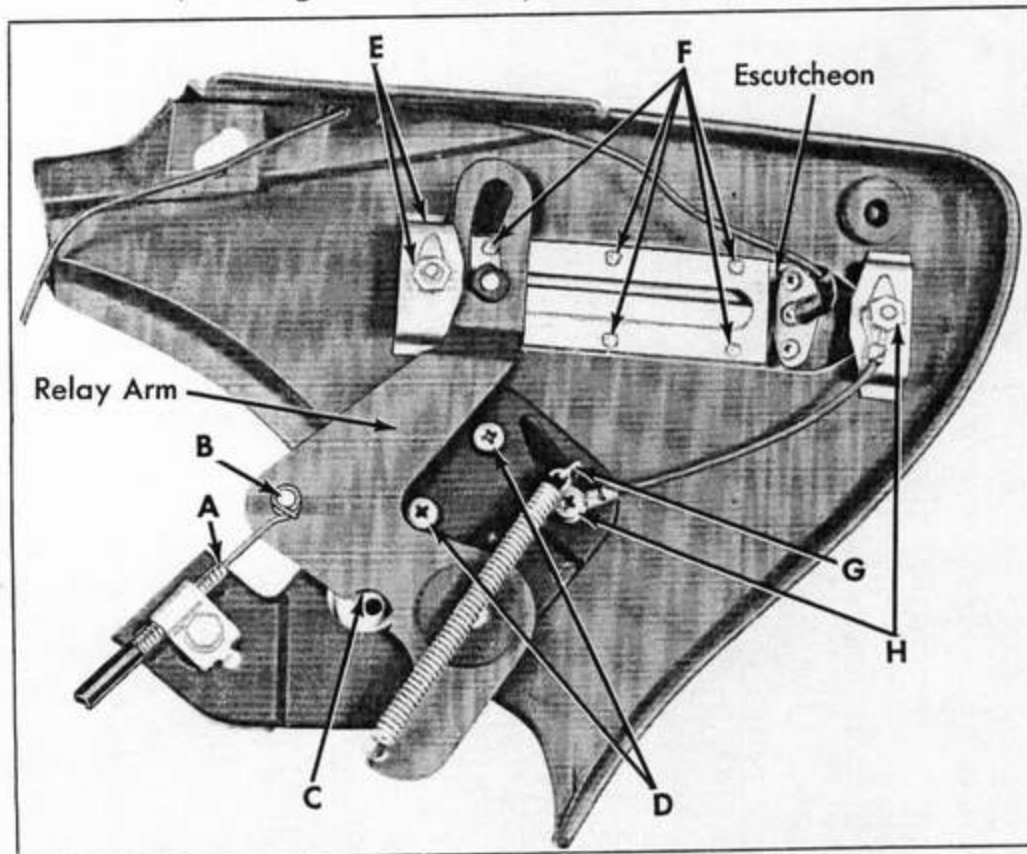
Fig. 2

The cable housing should be positioned so that the end of the housing is flush with the end of the relay bracket, see "A" Fig. 2,—not one coil past the clamp as stated in the 1961 Shop Manual. This will allow the ferrule to be positioned properly in the dust shield.

The cable wire must be installed on the pin so the wire is next to the relay arm and the coils of the cable extend toward the open end of the pin, "B" Fig. 2. If the cable is not positioned this way, it will kink where it enters the housing.

Early selector relays did not have the portion of the arm cut out as shown in "C" Fig. 2; consequently, the relay arm travel was restricted by the lower instrument panel extension screw. Any selector encountered with this portion *not* cut out should be replaced.

Some early selectors had washers under these two Phillips head screws, "D" Fig. 2. This could raise the height of the screws sufficiently so the head would contact the relay arm and restrict its travel. If washers are found under these screws, they should be removed.

This bracket should be positioned so that ends of bracket are exactly parallel with the escutcheon—not angled, "E" Fig. 2. The retaining nut should not be tightened to the point where the center of the bracket is bowed and distorted. Either condition could restrict the relay arm travel on the low speed side.

The rivets, "F" Fig. 2, on early

escutcheons had a tendency to pull away, and allow the escutcheon to separate, causing the lever to bind. This condition has been corrected on all cars after Engine No. 004270 by placing a drop of special adhesive over the staked end of each of the rivets. On those early escutcheons where the rivets have pulled loose, the escutcheon should be replaced.

The spring retaining tab, "G" Fig. 2, has been shortened to prevent contact with body sheet metal when the instrument panel extension is installed. If contact is noted on early relays, file approximately 1/16" off tab to eliminate interference.

In addition, one instance was reported where an electrical shock was received by the driver when the lock-in button was touched. This was probably due to a poor ground at either of the points, shown in "H" Fig. 2. To correct this problem, be certain that there is an external tooth type lock washer under each ground wire terminal, and that the teeth of the washer penetrate the painted metal of the assembly and the escutcheon bracket. This will assure adequate grounding.

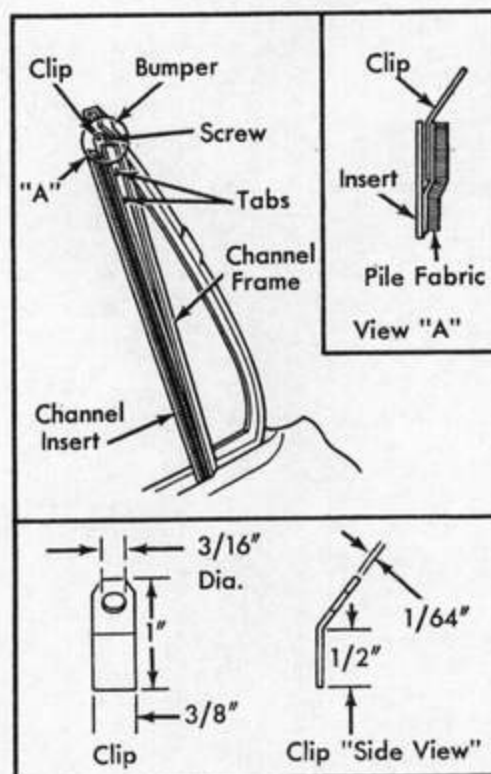
Fig. 3

ON some early production 1961 Cadillac cars, the front door window glass may crack in a diagonal pattern (from upper front to lower rear corners) when the door is slammed with the window in the partially open position.

This damage occurs due to the upper forward edge of glass contacting the ventilator division channel retaining tabs. If this condition is encountered, the following corrective steps should be taken:

1. Open the two tabs which secure the ventilator division channel insert to the ventilator division channel. These tabs are located below the division channel upper rubber bumper as shown in Fig. 3.

2. Pull division channel insert rearward to disengage insert from retaining tabs and securely clinch (flatten) retaining tabs against the ventilator division channel frame.

3. Install a small piece of waterproof sealing tape inside of division channel frame over each of the flattened retaining tabs.

4. As the two reworked retaining tabs no longer secure the division channel insert, make and install a non-corrosive metal clip between the pile fabric and metal backing of the division channel insert. See Fig. 3.

5. Remove the ventilator division channel upper rubber bumper.

6. Replace the division channel insert in the division channel and secure the new clip beneath the upper rubber bumper with the existing retaining screw.

7. Check inner surface of division channel insert to insure a smooth surface for glass contact.

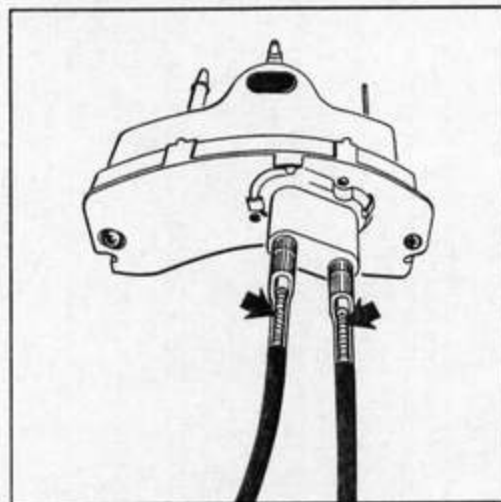
Fig. 4

PIR MANY servicemen are not aware of the two springs extending into the vacuum hoses from the parking brake release switch

mounted on the neutral safety switch, see Fig. 4.

These springs prevent the vacuum hoses from bending or pinching near the switch area, where they are routed at a sharp angle, eliminating any possibility of the parking brake unit failing to release automatically because of an obstructed vacuum supply hose.

Many times when a hose is removed, the spring also comes off and remains inside the hose unnoticed. Then it is positioned incorrectly when the hose is reinstalled. In this case, the spring should have been removed from the hose with a piece of hooked wire, and several coils of the spring rotated into the tube on the switch. The hose should then be slipped over the spring and on to the switch tube.

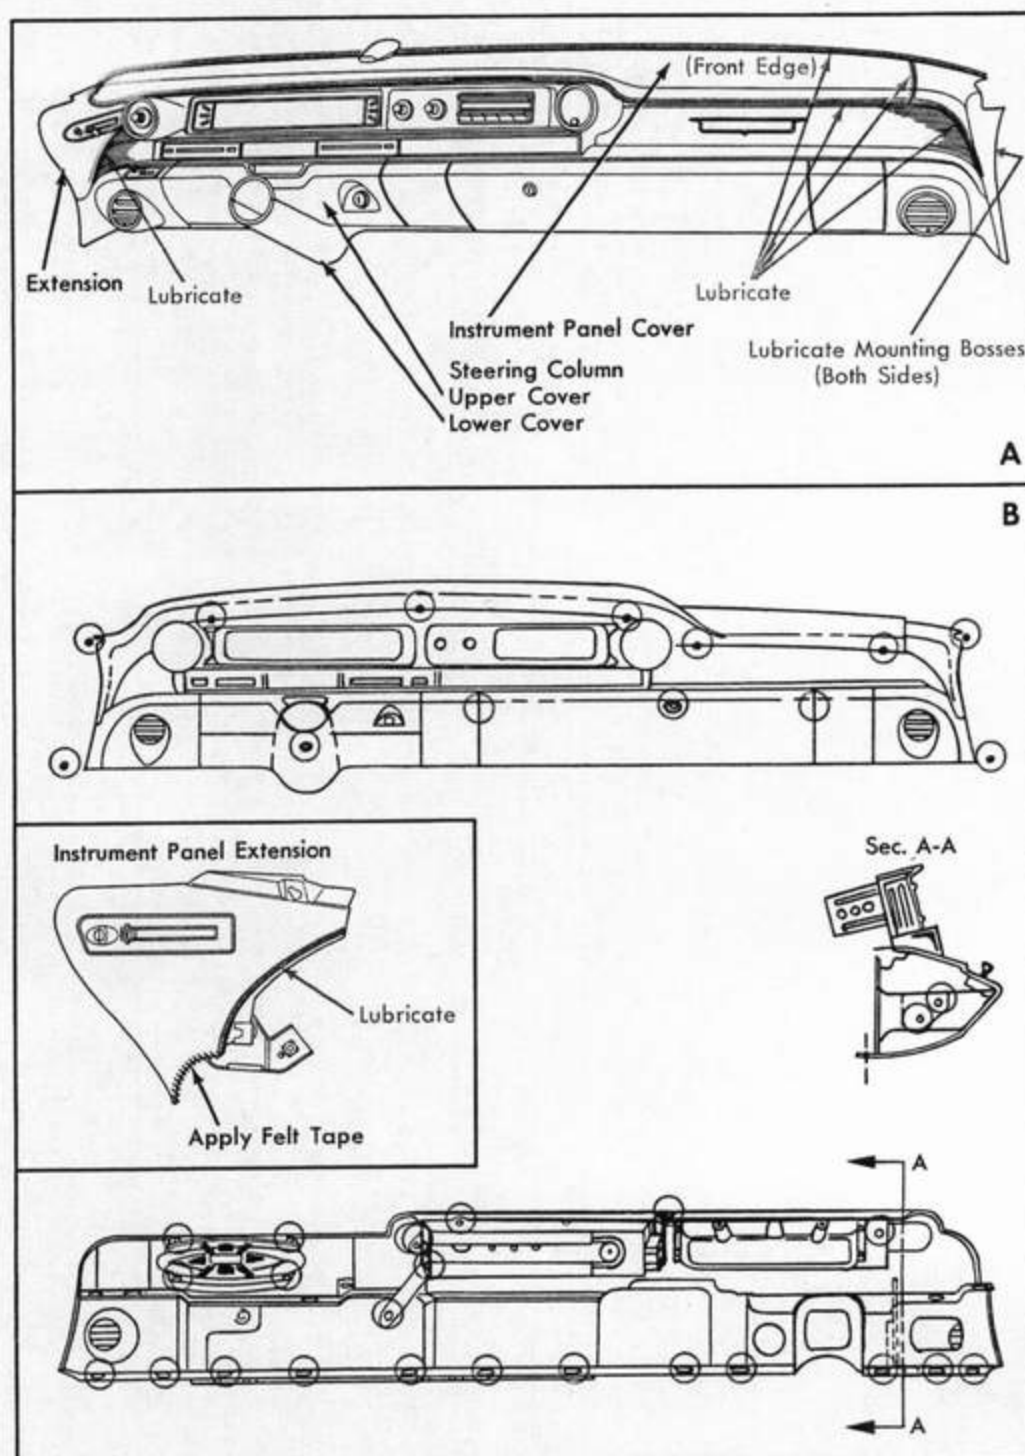
SOME servicemen have encountered miscellaneous friction squeaks and rattle conditions in the instrument panel assembly and its mounting area on 1961 cars.

The friction squeak conditions are usually caused by the frictional movements of vinyl, metal, or rubber parts against each other. In cases where vinyl and rubber parts are involved, the entire contact area should be lubricated with a light coat of 4X silicone, or Lubriplate. Use Lubriplate in all cases where refinishing may be necessary, to avoid complicating the repainting

process with silicones. Referring to section "A" of Fig. 5, and the insert of the extension in section "B", the green outlined areas in these illustrations locate most of the contact points and the areas to be lubricated.

Metal-to-metal squeaks, in most cases, are caused by improper seating or assembly of parts, or loose screws. The alignment of parts and the secure installation of the instrument panel and its components to the cowl may also be a factor. A good example of this is the chrome-plated headlight

switch housing contacting the cowl inner panel on some early cars. In this case, clearance would be secured by prying, or repositioning the instrument panel, depending on the amount of movement necessary.

In the case of dash rattles, locate and securely install any loose or missing screws. The green circles in section "B" of Fig. 5 are screw location points that should be checked for this possibility. In addition, any bowden cables or electrical connectors found loose and noisy should be taped.

In addition, some trim moldings, such as roof rail or windshield pillar garnish moldings, may develop creaky conditions. These may be corrected by applying felt-backed tape under the ends of overlapping moldings, and tightening the attaching screws. The felt tape should also be installed on the curved lower ends of the instrument panel extensions, as shown in the inset of section "B", Fig. 5.

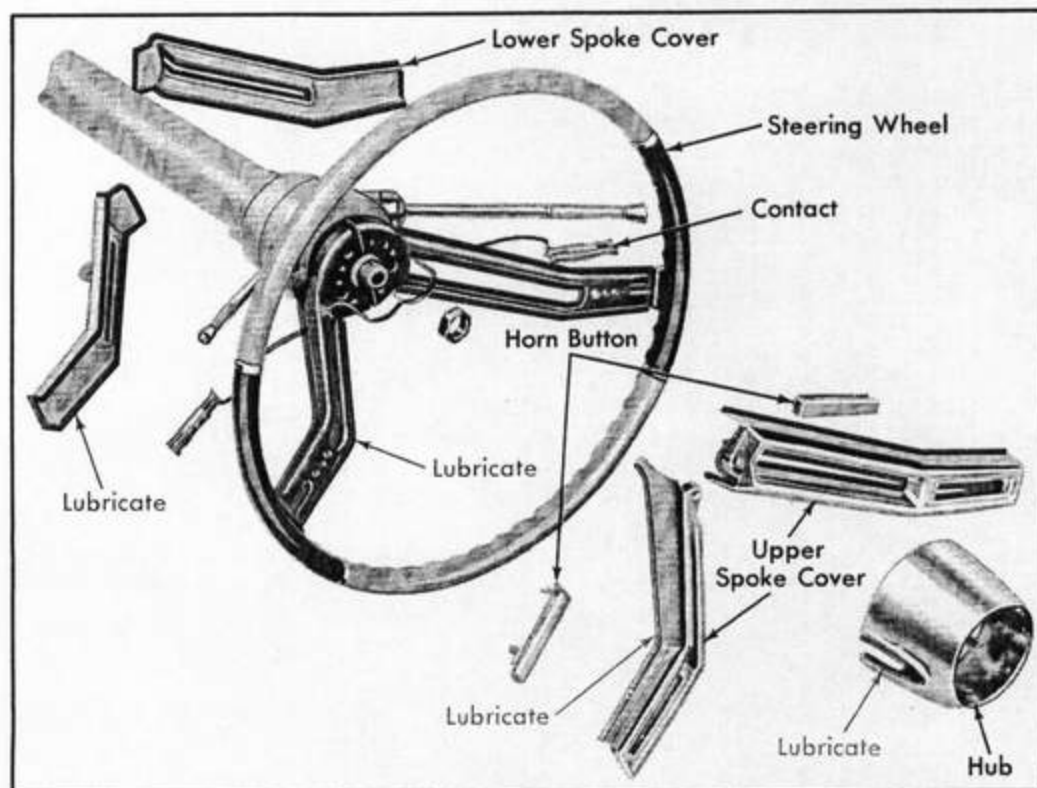
Fig. 6

Some of these noise conditions may be traced to the steering wheel assembly. A horn button may rattle, or a plastic-to-metal friction squeak may occur in the spoke covers.

The horn button rattle can be corrected by removing the spoke covers and bending the return spring up for greater preload. If the button bottoms before the return spring touches it, replace the horn contact switch with Part No. 1476487, improved type.

Also check the seating of the upper and lower spoke covers, and file off any attaching screw bosses as required to seat these parts. Lubricate all the plastic-to-metal and plastic-to-plastic points shown in green in Fig. 6, install the spoke covers, and tighten the screws securely.
