THE *Cadillac* MAY, 1973 SERVICEMAN

NEW POWER ANTENNA NOW SERVICEABLE

NEW WINDSHIELD WIPER MOTOR SERVICE PROCEDURES

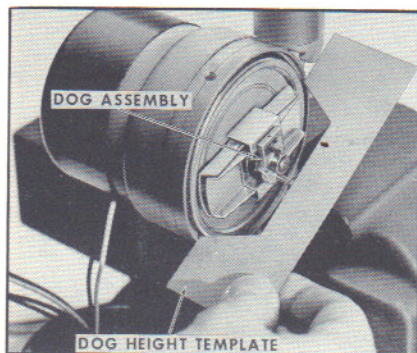
Fig. 2

2. Using template provided, measure distance between top of longest pin on dog to base of drive housing, Fig. 2. Adjust as necessary.

bly), measure distance between top of longest pin on dog to base of drive housing, Fig. 2. Adjust as necessary.

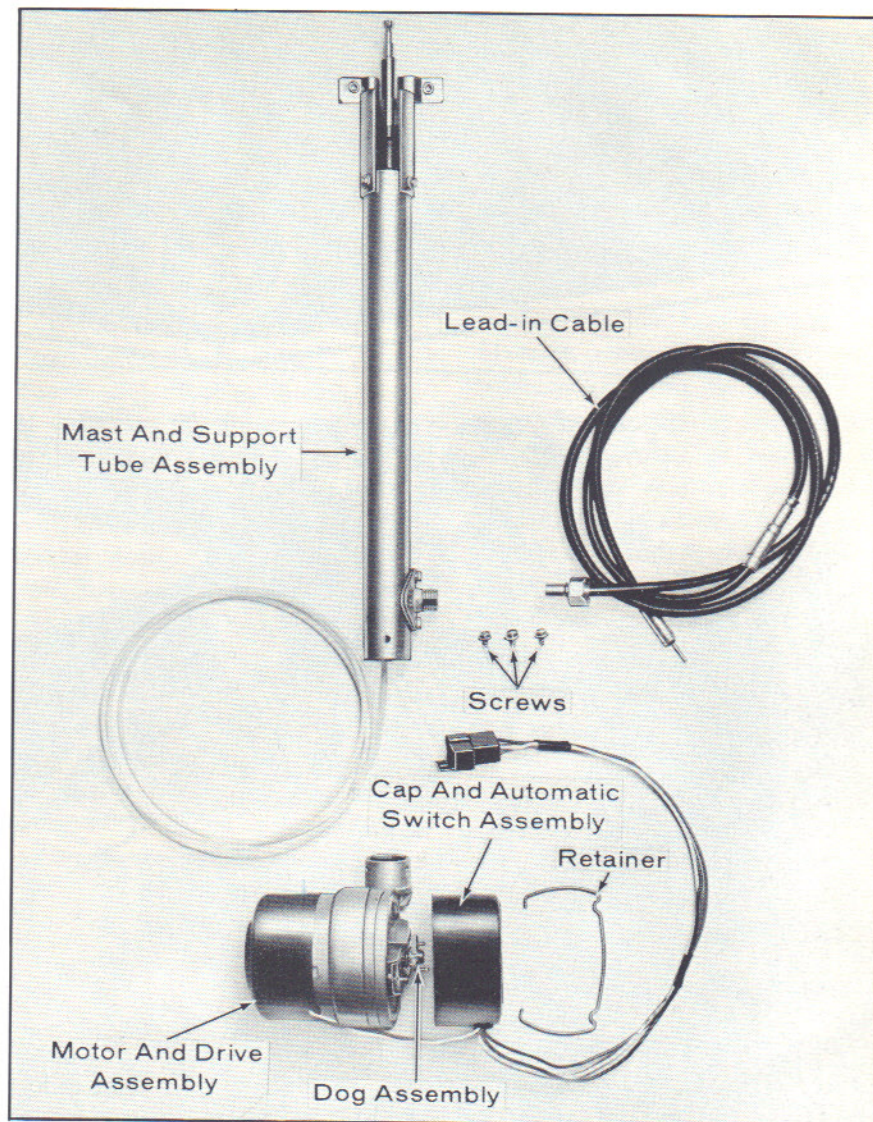
Fig. 1

THE optional power antenna is serviceable on late 1973 cars effective with approximate Broadcast Nos. 256600, 378900 and 437375. The new antenna can be identified by a retainer that holds the cap with its automatic switch assembly to the drive housing, Fig. 1.

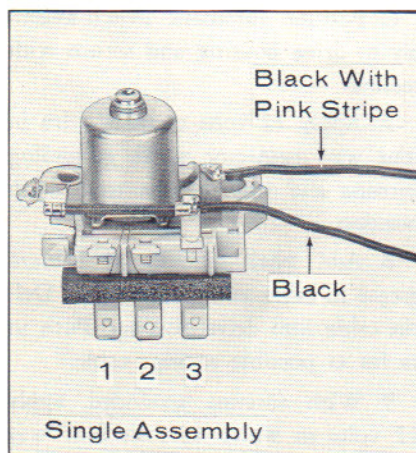
Fig. 3

THE windshield wiper motor assembly utilizes a combined park switch and terminal board assembly, Fig. 3, on later 1973 cars. Previously, the park switch and terminal board have been separate units, Fig. 4.

The separate-type and the one-piece assembly are not interchangeable because the one-piece assembly has a redesigned gear box, washer pump and washer pump cover.

1. Resolder leads to park switch and terminal board assembly as required, Fig. 3.

Note: Solder black wire to No. 3 terminal, and black-with-pink-stripe wire to fixed contact post.

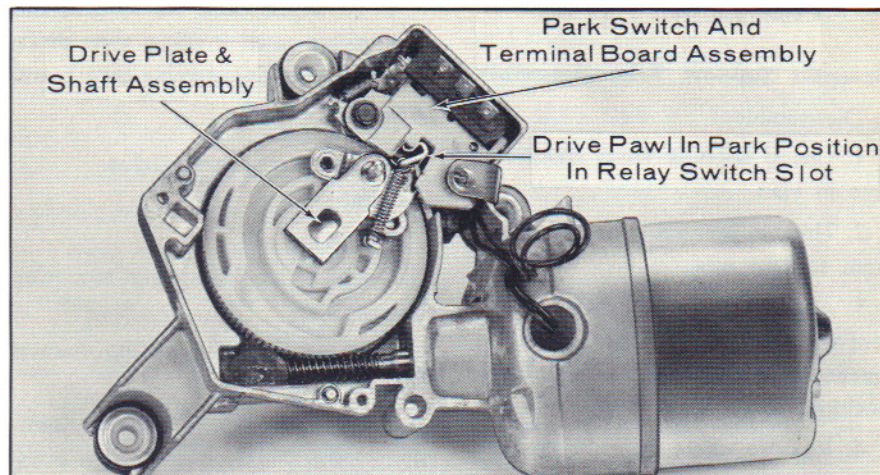
Fig. 5

2. If wiper gear drive pawl is in Park position, Fig. 5, manually trip the relay latch arm toward the relay coil, and apply feed current to the center terminal of the wiper terminal board and ground to the motor case. The wiper motor will turn the gear, moving the drive pawl out of the Park position in the relay slot.

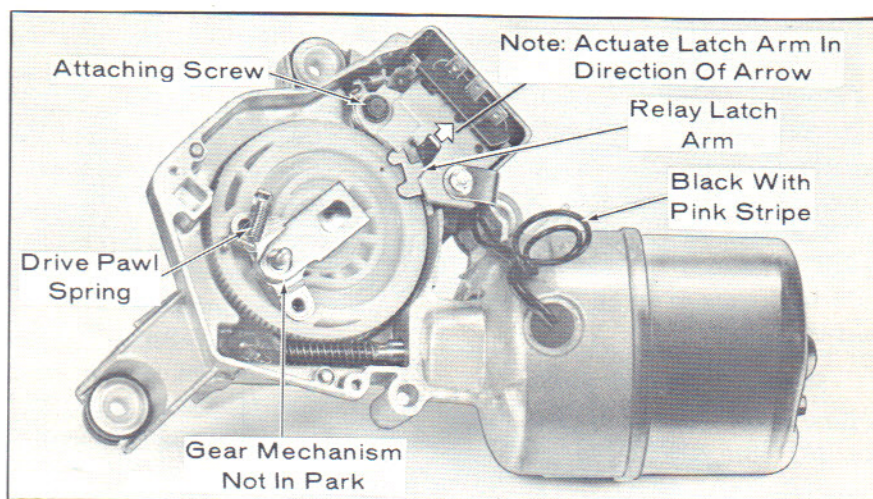
Fig. 6

If wiper gear mechanism is not in Park position (drive pawl away from latch arm, Fig. 6), proceed to step 3.
