V16 Restore – The New Engine Block

Chapter 2 - Discovery can be Painful

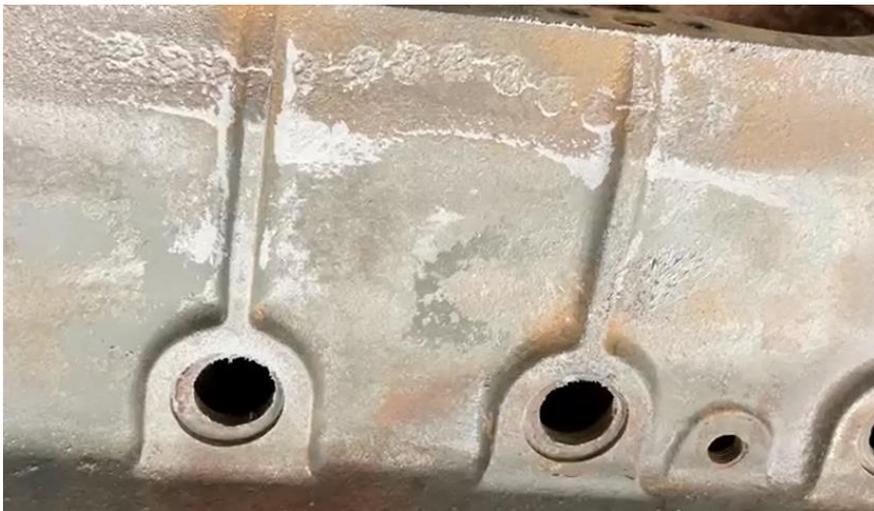
Here is a picture of a Magnaflux test. The bright spots are cracks. Some round plugs are also noticed. So that you can see the full process. I am also posting a movie of the test. RestoreCars and Mark Clayton are very good at sending updates including pictures and movies.

As mentioned, there is too much discovery to have a fixed price bid as with normal automotive work. The recommendation was to send the block to the expert cast iron repair facility, Lock –N-Stitch, in Turlock California. Their repair procedure is worth a review. See <http://www.locknstitch.com>

LOCK-N-STITCH informed us that they repaired 31 inches of cracks. Upon return of the engine it was again fitted to the CNC machine to correct any distortions incurred during repair. The vast percentage of cracks are plugged yet some need to be filled with brazing.

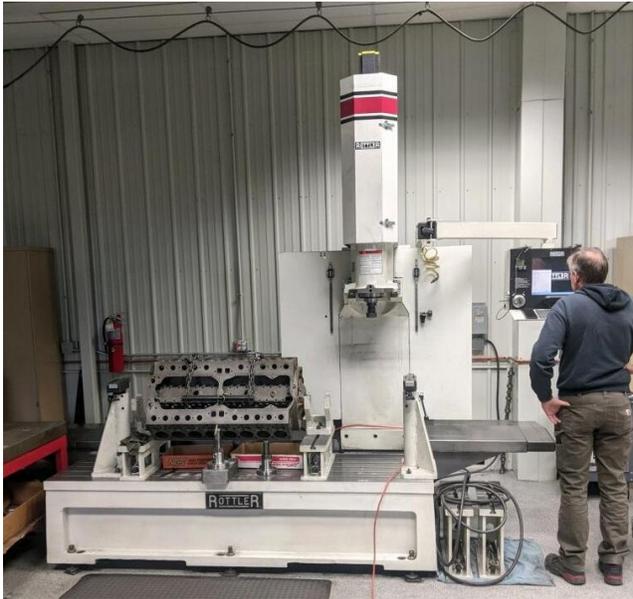
Engine on the CNC machine:

Fortunately the machinist programmed the entire block into a CNC machine and with that knowledge knew the entire engine configuration. The cylinder walls were also sonic tested to ensure enough material was available for any needed oversizing. The cylinder holes were measured and new pistons were ordered from Arias. Lead time at Arias was a few months. Shipping the block took a few weeks and with LOCK-N-STITCH shop backlog being a few months with added the inclusion of COVID delays we added about 4 months to the timeline.

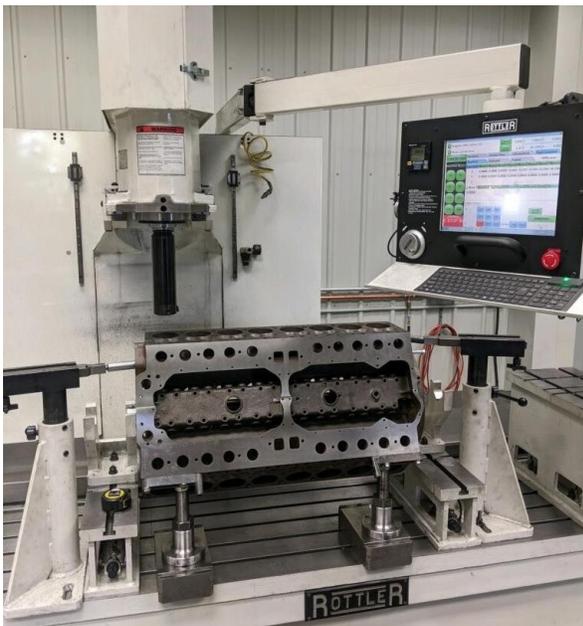
Back from crack repairs and the engine returns to CNC to check for any needed corrections.

The cylinders were slightly corrected to extend at the same angle from the crankshaft.

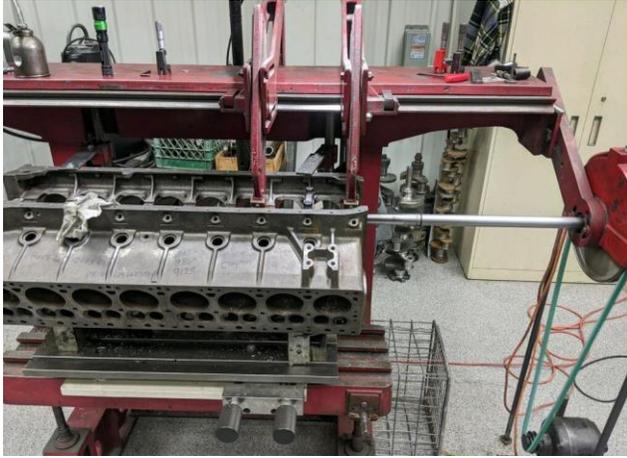
Align boring to correctly size the newly surfaced mains.
