V16 Restore – Pulleys and Pumps

Chapter 4 – Discovering How Many Miles

This is the fourth of many articles covering my experience restoring a 1940 V16 Town Car. For an introduction, start with the first chapter.

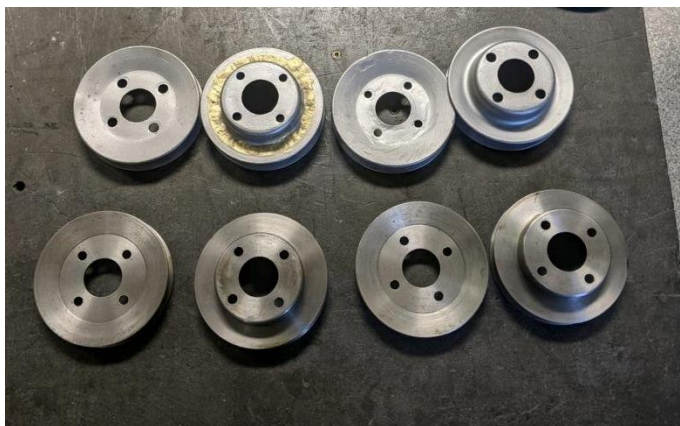
Pulleys

The top row is the old set and the bottom row are the replacement pulleys. The new pulleys are available from Cadillac Parts Ltd in New Jersey. Website is <http://www.cadillacpartsltd.com/>

When we saw the repaired damage along with new pulleys being available, we ordered the set. It was our expectation that the undamaged pulleys were likely suffering from metal fatigue.

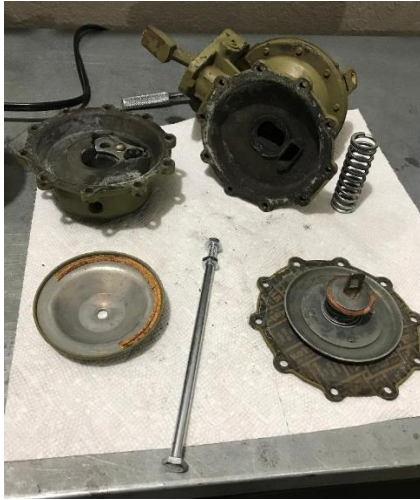
Inside the pump, find the needed diaphragm parts. The fuel pump operates the vacuum pump with a pull. The Cadillac needs a push rod from the tappet to the diaphragm. The long $\frac{1}{4}$ hardened bolt will be cut to length.

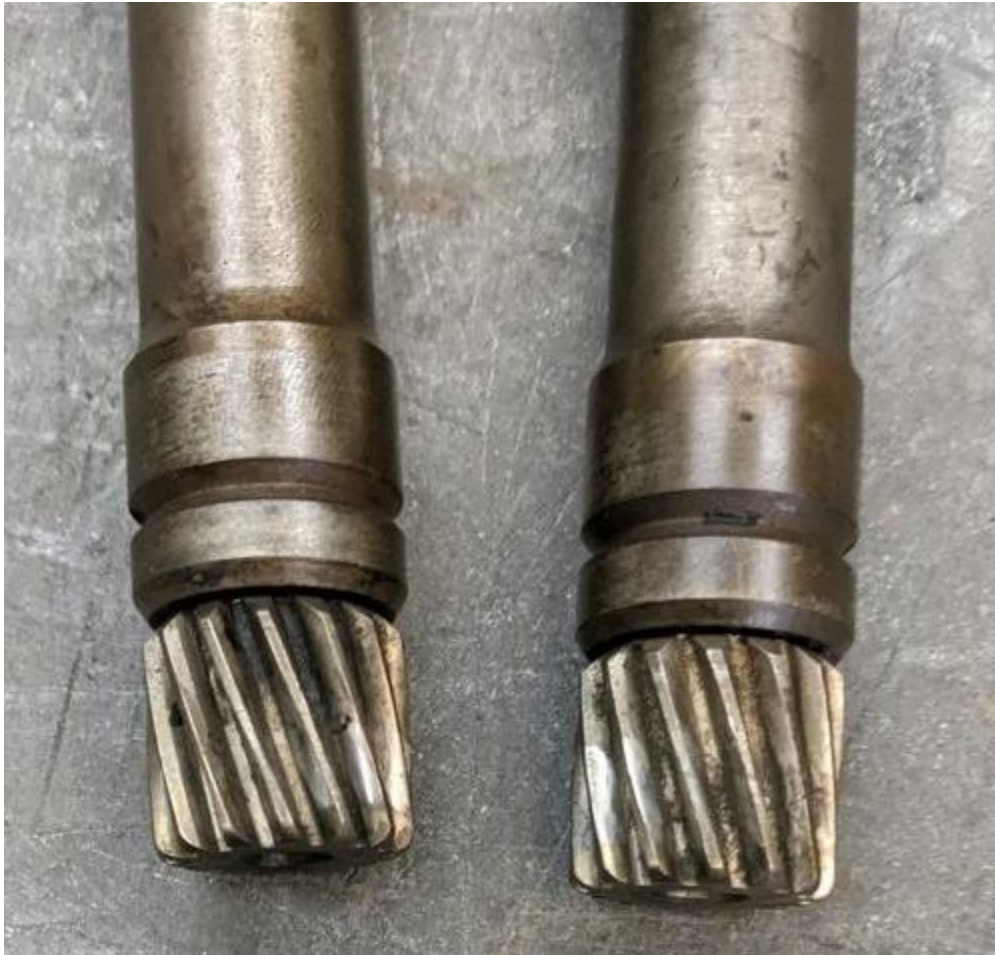
Pictures of worn gears (I don't currently have pictures of the new gears):

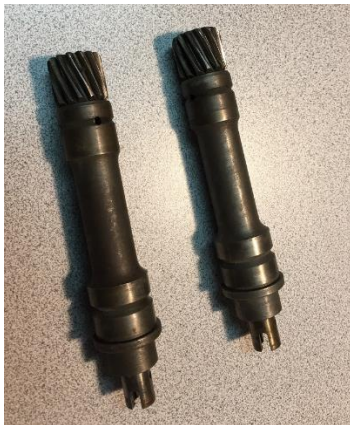
The pair of worn gears in their housings. The housings were worn and out of round. Al Meekins knew this without having the gears. He made the replacement gears with enlarged shafts and bored out the housings to match.

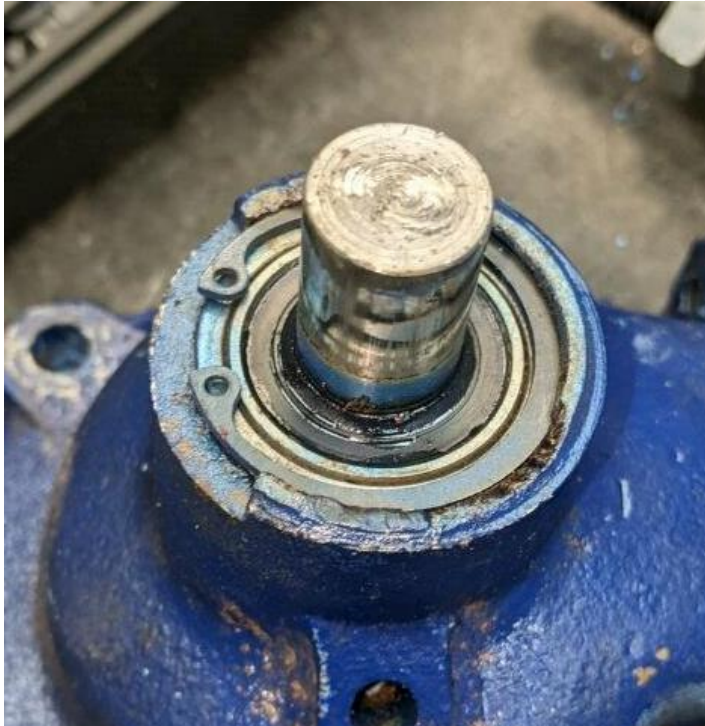
When new parts are available the restoration shop prefers using those. Cadillac Parts Ltd (mentioned above in this chapter) advertises new pumps at \$850 each. So I called and ordered a pair. Mike Gadaletto advises me these pumps are being built and would be available in a few months. After many months, the pumps remain elusive. Mike's suppliers are failing him. So looking at the current pumps, they are marginally rebuildable.

The castings are fragile, note around the snap ring the broken casting:

As of this date, no resolution on the water pumps. Status as of the time of this writing, Cadillac Parts Ltd is waiting for the foundry to cast replacement housings. The first set received, upon machining they crumbled. We either will rebuild the old ones or dynamometer testing will wait for the new ones.
