THE CADILLAC SERVICEMAN

PUBLISHED BY
CADILLAC MOTOR CAR DIVISION
DETROIT, MICHIGAN

NOVEMBER
1960

VOLUME XXXIV NO. 11
© GENERAL MOTORS CORP.

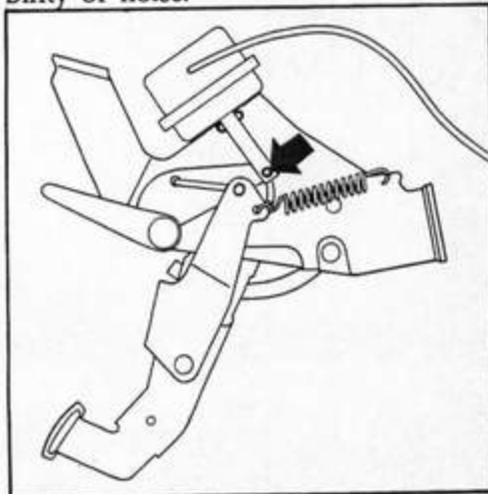
Fig. 1

PIR A RATTLE condition may develop in the parking brake assembly, due to excessive play in the vacuum unit release linkage, on some 1961 cars before approximate Engine No. 019000.

This condition can be corrected by stretching a small "O" ring, Part No. 1453923, or similar ring over the rivet head, as indicated in Fig. 1.

Cars after the above Engine Number will have a spring wave washer added at this location to eliminate any possibility of noise.

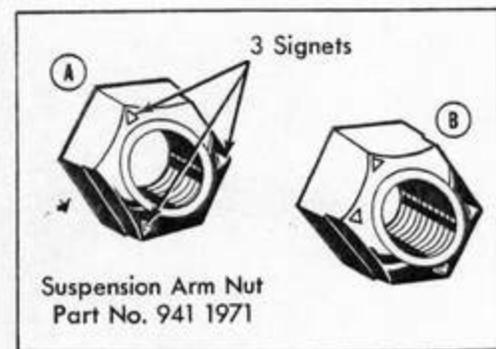
Fig. 2

AT the very start of 1961 production, it was found more satisfactory to install the bolts that hold the upper front suspension arm shaft to the frame with the bolt heads down, rather than up, as originally planned. With this arrangement, the bolt heads contact the frame and the Stover type lock nut tightens against the harder material of the suspension arm shaft.

This production change makes it necessary to change the torque specification on Pages 4-26 and 4-39 of the 1961 Shop Manual from 110-120 foot-pounds to 55-70 foot-pounds, as the drive for tightening is now applied to the nuts rather than to the bolt heads.

When making this change in your Shop Manuals, be sure to cross out the word "bolts", as this new specification applies only when the wrench is used on the nuts. The suspension arm shaft-to-frame nuts should be torqued to 55-70 foot-pounds. This torque should be checked during Pre-Delivery Conditioning.

Servicemen should also check for the correct *type* Stover nuts at this location on cars before Engine No. 007000, by cleaning the top of the nut and counting the small embossed signets on the top edge of the nut. A correct upper suspension arm shaft nut, Part No. 9411971, will have three identifying signets, see "A" Fig. 2. A contrast to this would be the Stover nut "B" with 4 signets as shown in Fig. 2. If a car is encountered with nuts having 4 signets, remove them and install three-signet nuts, Part No. 9411971, tightening them to 55-70 foot-pounds.

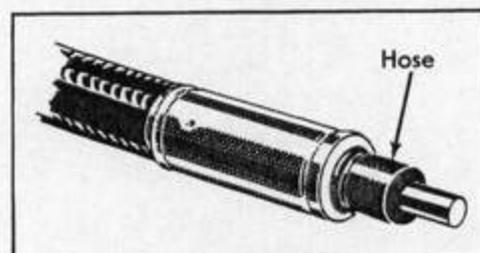
Fig. 4

When an early 1961 production car is encountered with a radio that is dead or one that operates intermittently, check for this condition first, by pulling the antenna lead out approximately ¼", before removing the radio.

If the condition can be corrected by pulling the antenna lead out in this manner, remove the antenna lead from the radio and place a piece of ¼" rubber hose approximately ⅛" long over the lead pin, Fig. 4; then plug it back into the radio. Hose from the Heater or Air Conditioning vacuum controls can be used.

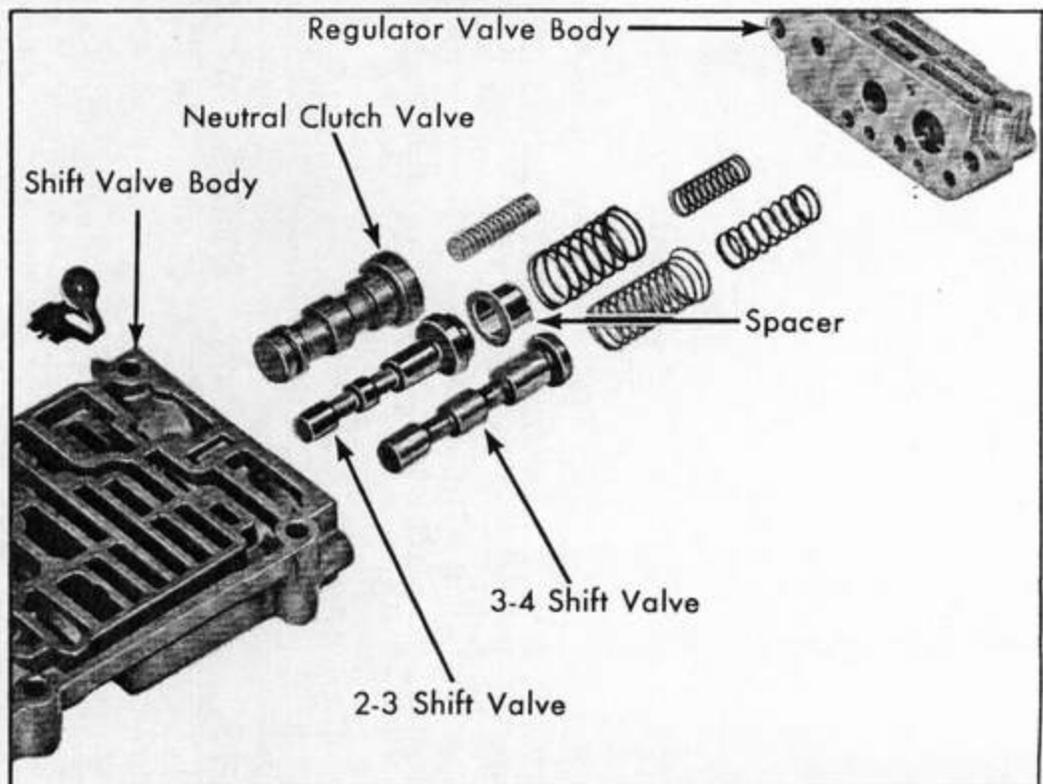
Fig. 5

WHEN overhauling the shift valve body from a 1961 or late 1960 Hydra-Matic transmission, an additional spacer will be noted which is not pictured in the Shop Manual. This spacer fits on the end of the 2-3 shift valve with the rim of the spacer against the large land on the valve, as shown in Fig. 5.

A steel backing washer has also been added between the rear clutch hub and rear unit clutch cover to reduce galling of the bronze thrust washer and reduce wear on the clutch cover. The bronze

thrust washer is positioned next to the rear clutch hub and the steel backing washer is positioned between the bronze washer and the rear unit clutch cover with the flange on the backing washer toward the clutch cover.

Both washers are used on all 1961 and some late 1960 Hydra-Matic transmissions. The washers are included in one service package, Part No. 8619969, and will replace and be completely interchangeable with the single-type bronze washer, and are applicable to all 1956-1961 transmissions.

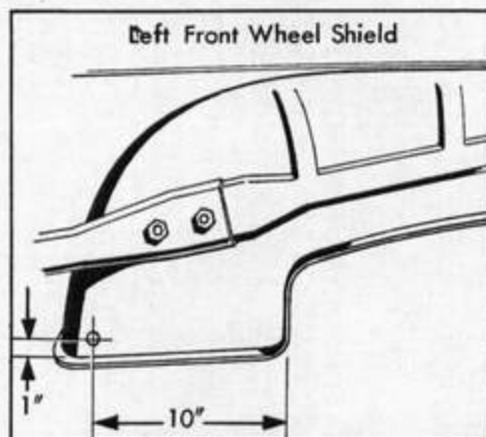
Fig. 6

However, it was found that some cables tend to reposition themselves, especially when strapped together, causing an interference and chafing action at the steering gear flexible coupling.

The plastic anchor strap, similar to

the ones used to route and position electrical cables, can be easily installed by drilling a 1/4" hole at the specified location, as shown from inside the front wheel shield in Fig. 6. Mark the location from the underhood side, and drill from the under fender side. Then press the strap anchor peg into the hole, route the cables carefully in this area, and lock them in position with the strap.

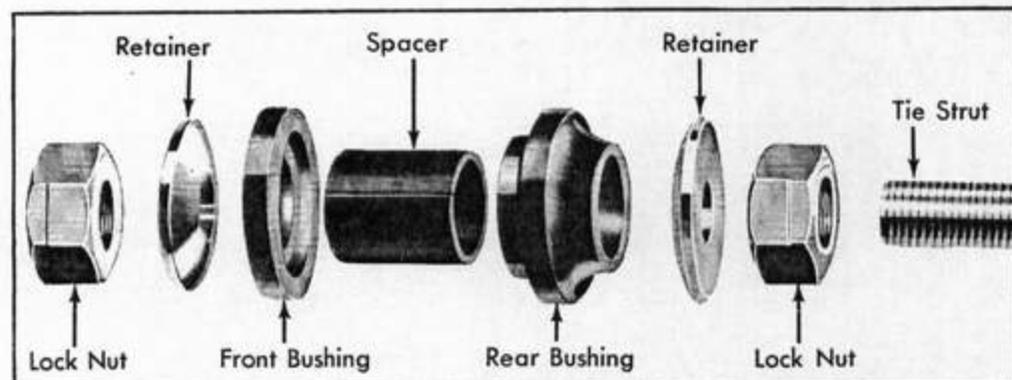
Fig. 7

This condition can generally be distinguished by a creaking noise in the front suspension, not attributable to ball joints or upper bushings, but caused by the contact between the spacers and the frame. In addition, wheel "thump" resulting from excessive fore-and-aft movement of the front wheel when stopping was also

When any of the above symptoms are noticed, the rubber bushings assemblies on the tie strut should be removed so that the spacers and retaining washers can be examined for damage and replaced if necessary.

New stover nuts should always be installed whenever the tie-strut is disassembled at this point. If the new stover nut is thread onto the tie-strut and loses its self-locking qualities on rough threads, it should be replaced with another nut. Threading the first new nut on the tie-strut should clean the threads sufficiently so the end nut can be properly set and torqued.

In addition, torque the 3/4 - 16 stover nuts that preload the tie-strut rubber bushing retaining washer to 30-40 foot-pounds instead of the 55-70 foot-pounds previously recommended. This torque change, in addition to a closer inspection of the tie-strut threads, was instituted in production at Engine Number 010483.

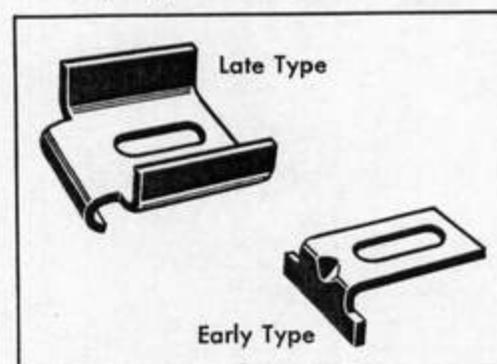
Fig. 10

IF an owner of an early 1961 Cadillac, prior to Engine Number 004463, complains of the glove box door falling open, an effort should be made to correct this condition by adjustment of the striker.

In cases where adjustment fails to correct this condition, a more durable striker, Part Number 1477268, and attaching screw, Part Number 9417414, should be installed.

An adjustment shim, Part No. 1477267, is also supplied and available from the Factory Parts Warehouse, along with the striker and attaching screw, to be used if necessary to make closer contact between the glove box door attaching latch and striker.

To eliminate the possibility of glove box doors falling open on future cars, this change was incorporated in production beginning with Engine Number 004463. The two strikers, late type and early type, are shown in Fig. 10.
