Three-Terminal Current and Voltage Regulators Are Supplied for Service Use on Previous Models

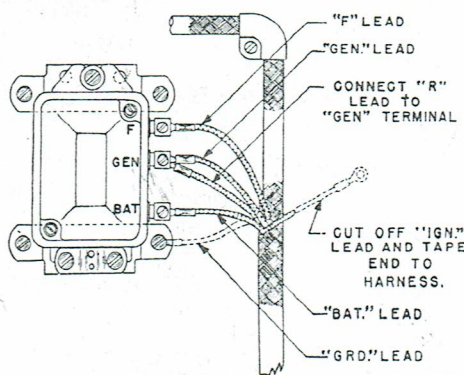
THE SIX-TERMINAL current and voltage regulator originally installed on 35-50, 36-Series and 37-70, 75, 85, 90 and 38-75, 90-Series Cadillac and La Salle cars is not furnished for service replacement. Instead, a special three-terminal regulator unit has been supplied.

The changes in connections required when installing replacement regulator 1886970 are shown at the left; those required when installing regulator 005817 are shown at the right.

Mounting the new regulator unit on the dash presents no problem, as the same screws and mounting holes are used, but it is important that the connections be made exactly as indicated in the illustration (at left below).

Connect the "F" lead to the "F" terminal, the battery lead to the battery terminal, and the generator lead to the generator terminal. Also connect the "R" (starting relay) lead to the generator terminal.

Cut off the ignition lead close to the harness opening and tape end of wire to harness. Lastly, install terminal of ground lead under one of the regulator bracket mounting screws, cleaning off any paint or corrosion to insure a good ground.

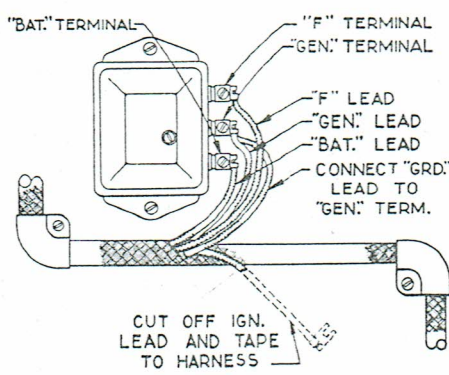
A different three-terminal regulator is also supplied for service use on those 37-50, 60, 65 and 38-50, 60, 60S, 65-Series cars on which a five-terminal voltage regulator, Part No. 005817, was used as original equipment.

In connecting the replacement regulator, follow the illustration at the right below. Connect "F", generator, and battery leads to the corresponding terminals; connect ground lead to generator terminal also; and cut off ignition lead at harness opening and tape to harness.
