# 1954-1959 Cadillac LED lights tech-tip

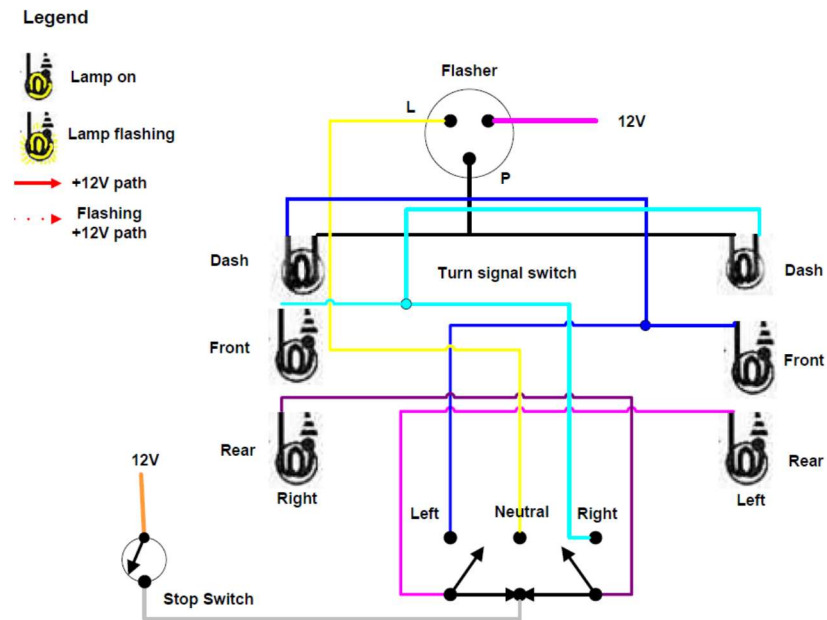
Fig. 1 shows the wiring arrangement for the signal/break lights through the signal switch.

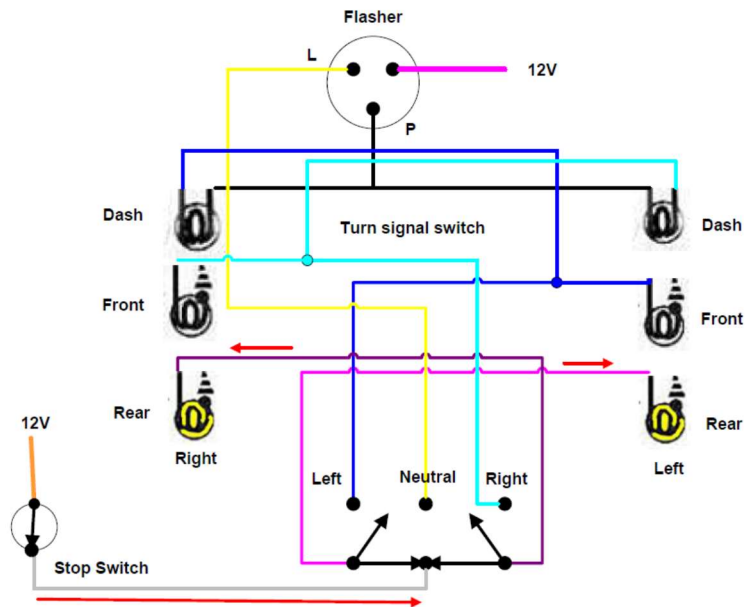
Fig. 2 shows the path for the +12V from the stop switch to the turn signal switch in the "Neutral" position to extend the path to the brake lights.

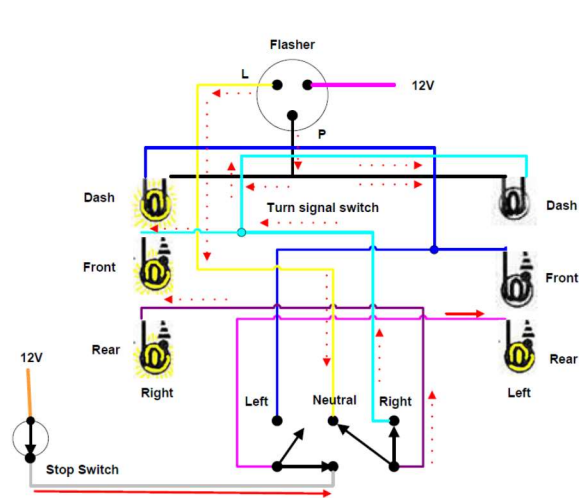
Fig. 3 and 4 below shows the flashing path from the flasher in operation to both the “L” and the “P” terminal. It also shows the dash lights path (working side) for the ground takes place through the opposite dash bulb filament and up the same side front lamp ground.

Since the filament of the front light bulb is very low (in the range of 6 ohms) the bulb filament would act as a resistor straight to the ground source.

If either “dash” bulbs (filament resistance) are mismatched, a burn/open front light(s) filament or a bad/open ground at the front bulb the path for ground will be changed causing both dash bulbs to be in series to each other extending their path over to the working flashing side.

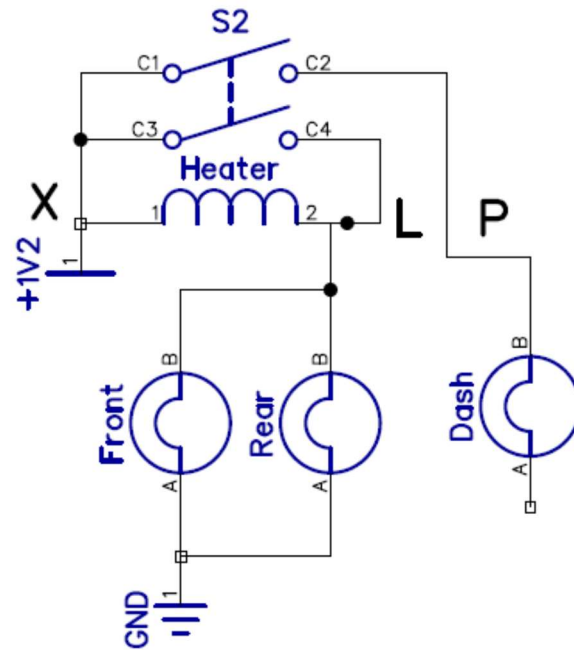
Fig. 5 below depicts a basic layout for this application with the mechanical flasher, the “dash bulb” is not connected on this drawing details on how is done can be found under Fig. 1-4 above.

Since the “P” is not part of the load, the flasher cycle is determine by the “L” filament resistance on the front and rear bulbs which are connected in “parallel” to each other at the turn signal switch.
