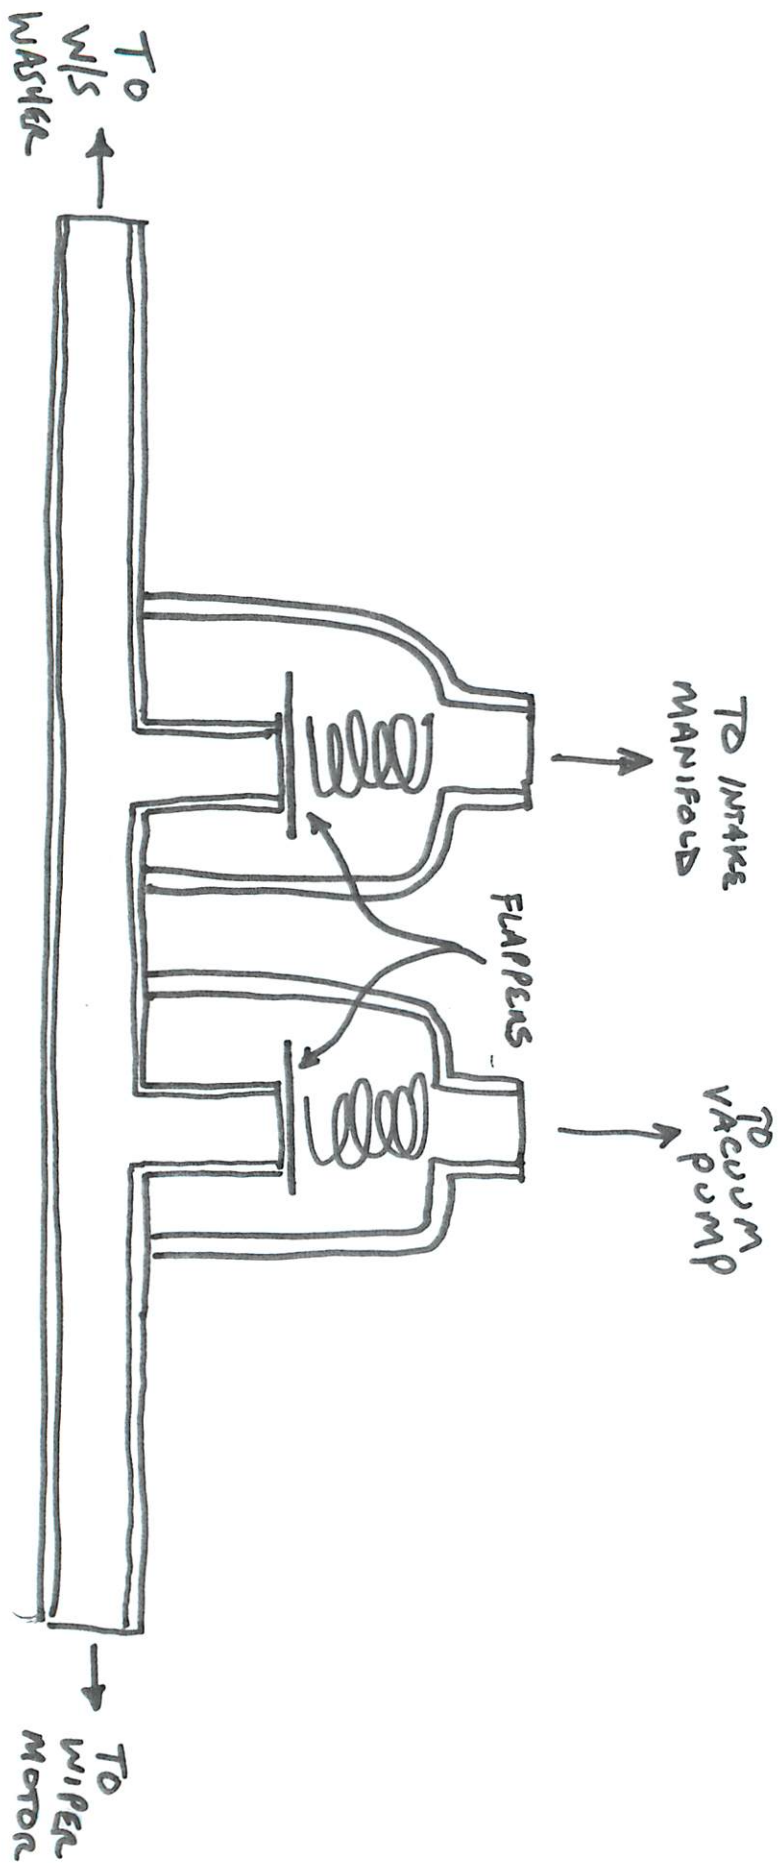
Figure 1 (ENGINE OFF, BOTH VALVES closed)

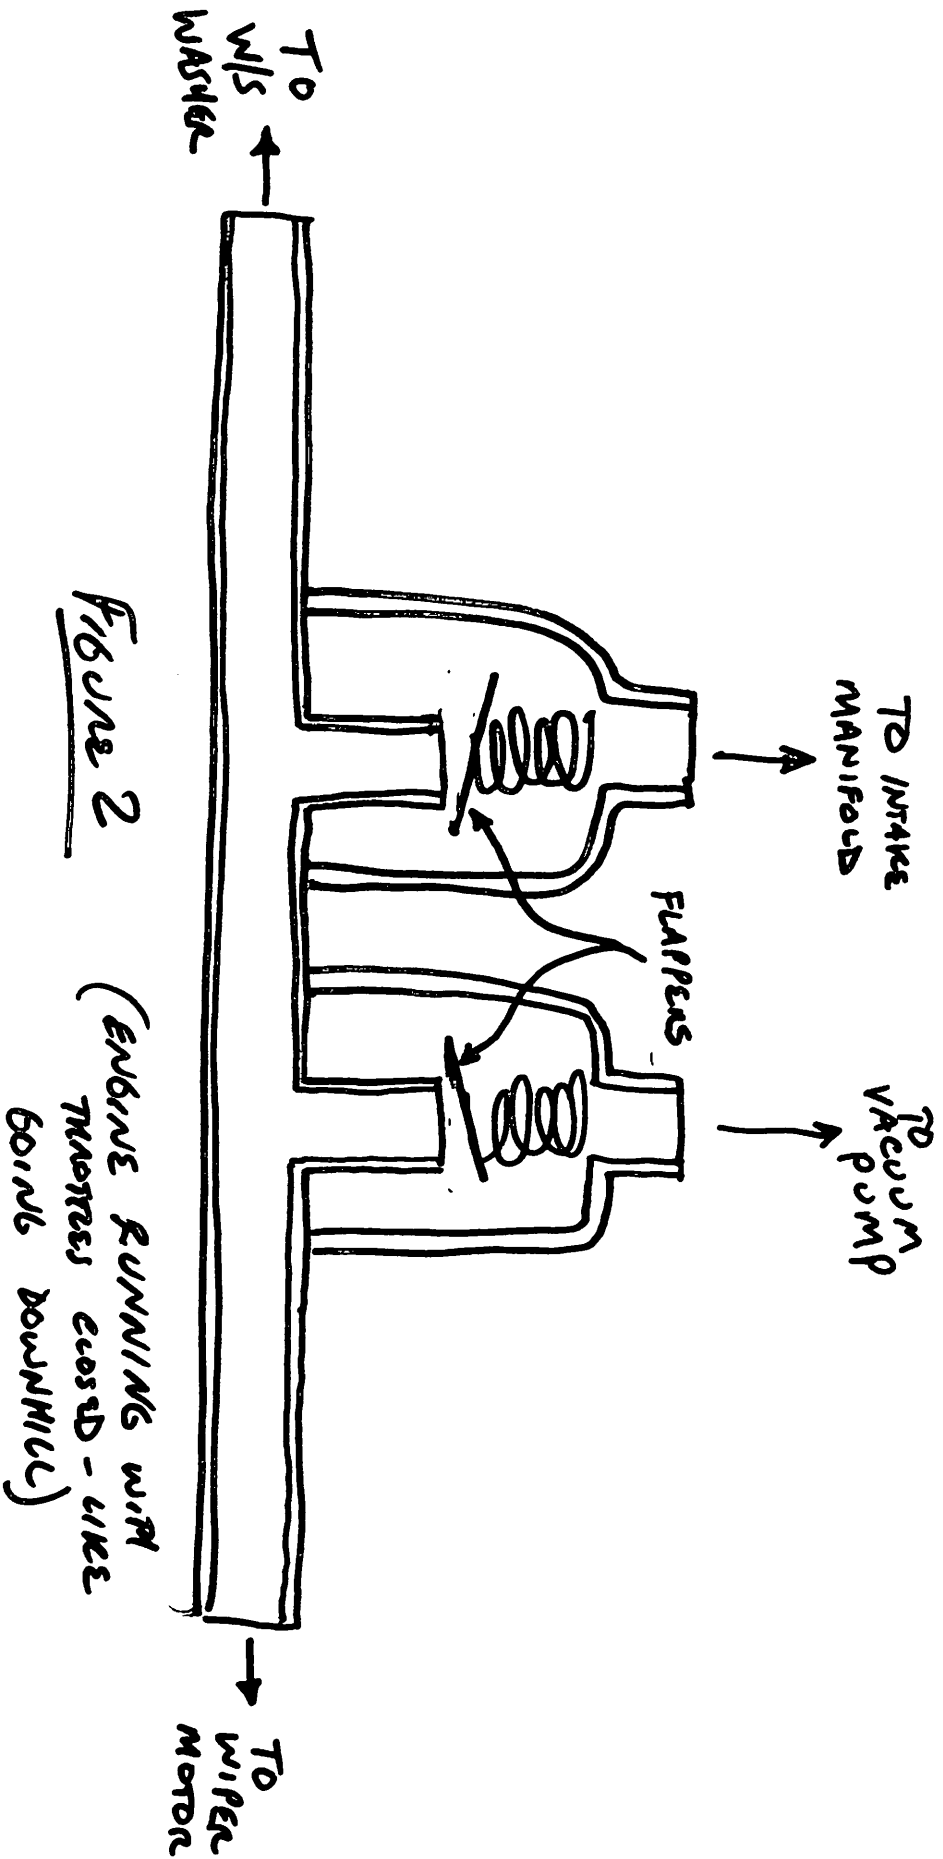
Figure 2 (ENGINE RUNNING WITH THROTTLES CLOSED - LIKE GOING DOWNHILL)

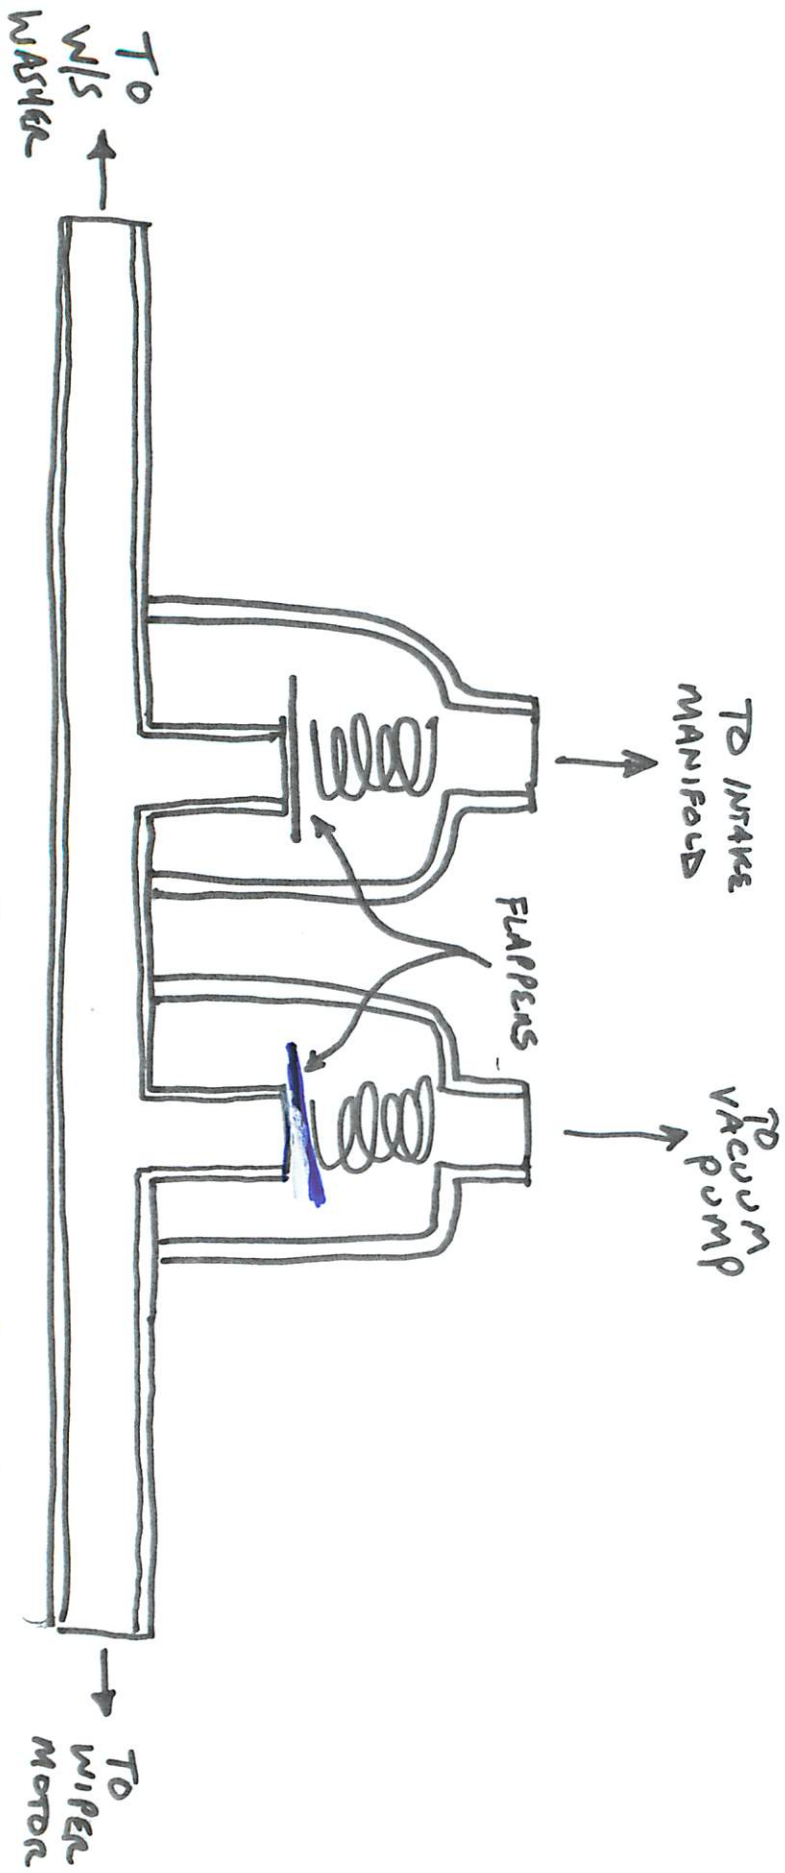
FIGURE 3

(ENGINE RUNNING WITH  
OPEN THROTTLE AND LITTLE  
MANIFOLD VACUUM -- LIKE  
GOING OFFHILL)
