V16 Restore – Engine Machine Work

Chapter 5

This is the fifth of many articles covering my experience restoring a 1940 V16 Town Car. For an introduction, start with the first chapter.

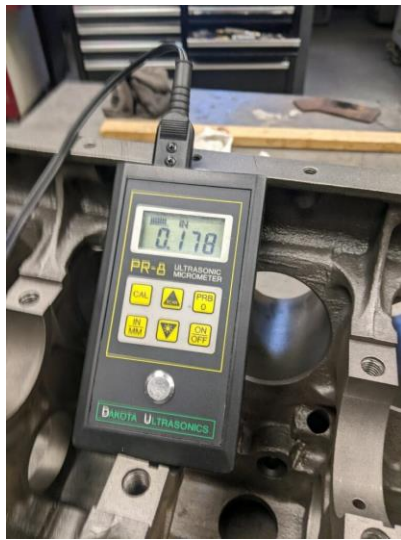
Prior to enlarging a cylinder, sonic testing measures cylinder wall thickness to ensure enough metal remains.

On this engine, minimum wall thickness:

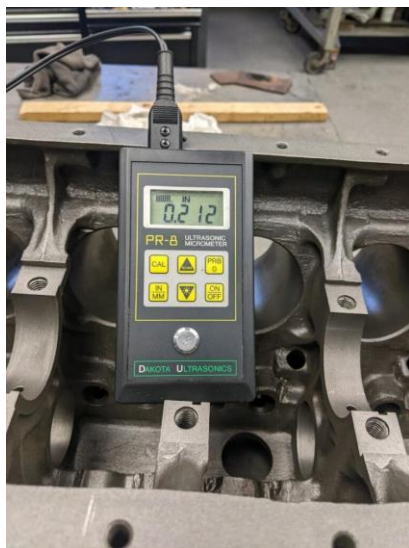
On this engine, maximum wall thickness:

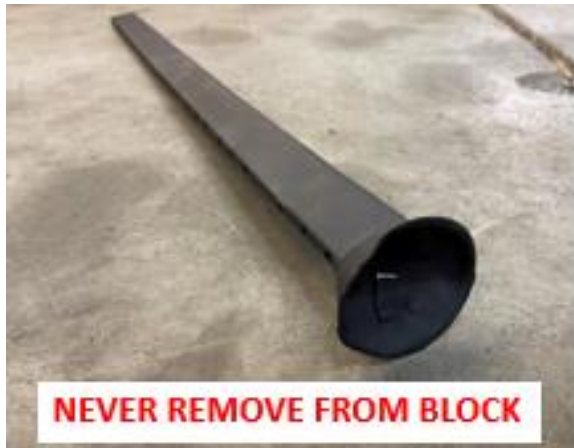
I'm uncertain of the proper name for this part, it is easily a manifold. Installed in the engine block, it exists behind the water pump and directs coolant flow inside the block. For the V16 one exists for each bank of cylinders. During engine cleaning, the machinist removed one. The removal caused extensive damage. The decision was to leave the second one in place. Similar damage is reported to me by three different machinists on Gen 2 V16 rebuilds.
