Anyone interested in knowing what is inside one of the old condenser/capacitors; this one is the 1191095 .3mf for the generator side.

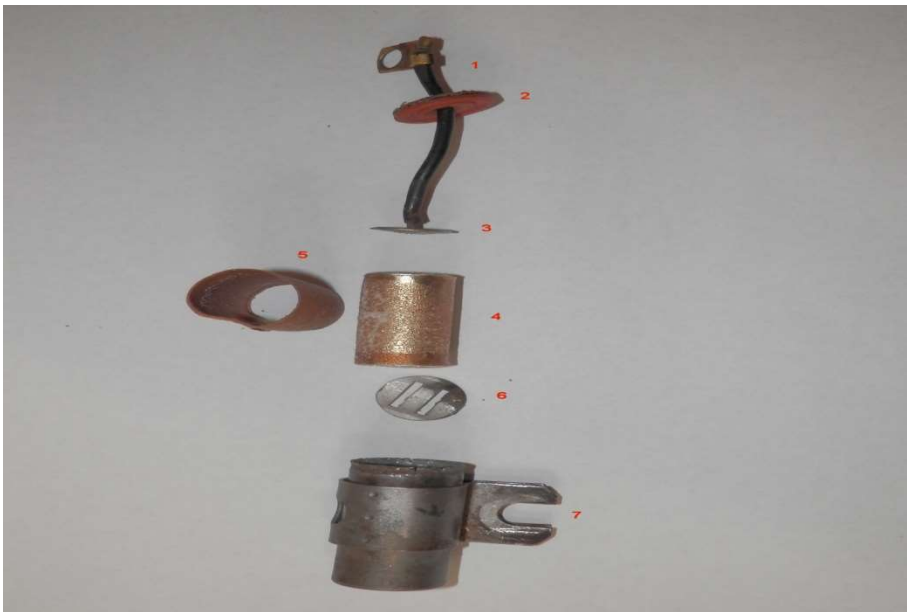
The wire (1) has the seal cap (2) a piece of metal with a rubber seal on both sides at the end there is the metal plate to contact the top end of the condenser/capacitor aluminum foil (4). The other end of the condenser/capacitor there is a spring type metal place (6) which seat at the end of the canister (7), wrapping these 3 and 4 is the paper insulator (5) from touching the canister wall inside.

Everything 3, 4 and 6 is pressed tight inside forcing 6 to keep contact at the bottom for the ground path.

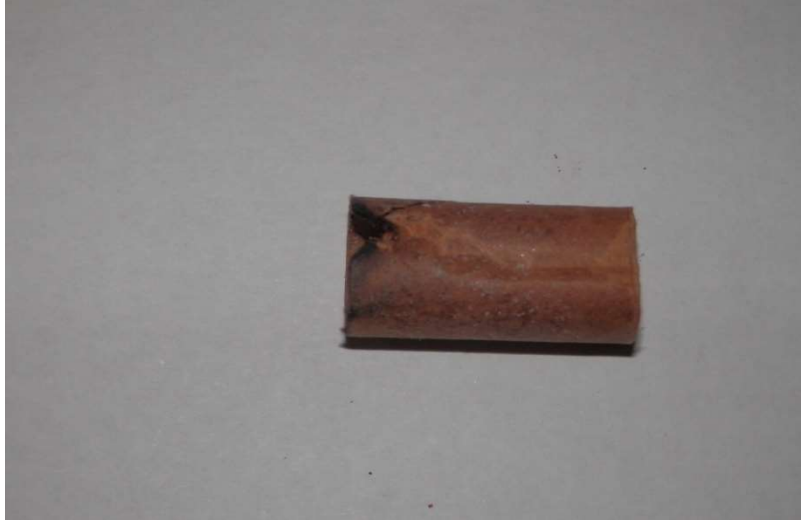
One of most common failures on the old condenser/capacitor outside from age deterioration of the condenser/capacitor material is possible poor ground contact at the base; below you will notice this one had burn marks at the bottom of the paper insulator from arcing between the bottom of 4 and 6 to ground.

My plan is to replace the old aluminum foil type with a newer capacitor, now .3mf may be hard to find today the closes one would be .33nf (or 330000pf). This one is rated at 400V
