CADILLAC SERVICE ROUND TABLE
Service Summary

January 1960

M^cGOOD RIDES AGAIN
(ON CADILLAC AIR SUSPENSION)

AIR SUSPENSION SERVICING

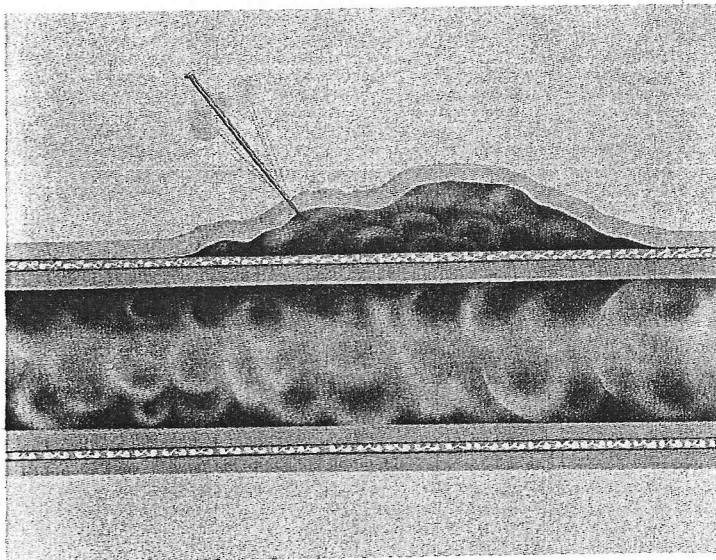
If you look under the hood of a '58 or early '59 Cadillac equipped with Air Suspension, and see an inflated high pressure hose between the compressor and accumulator tank, don't think it's about to explode. In fact, it may not even be necessary to replace the hose.

The inflation is caused by air seeping between the outer rubber skin and the braided wire of the hose. We can correct the condition by puncturing a small hole in the outer rubber skin . . . since it only serves as a protective coating. However, if the hose looks unsightly after puncturing it, a new pressure hose may be necessary.

When replacing a high pressure hose, use the late type hose -- the one perforated with tiny little holes that allow the air which causes inflation to seep out, but will not let moisture seep in. The perforated hose was used in production on 1959 model cars -- starting with engine number 043499.

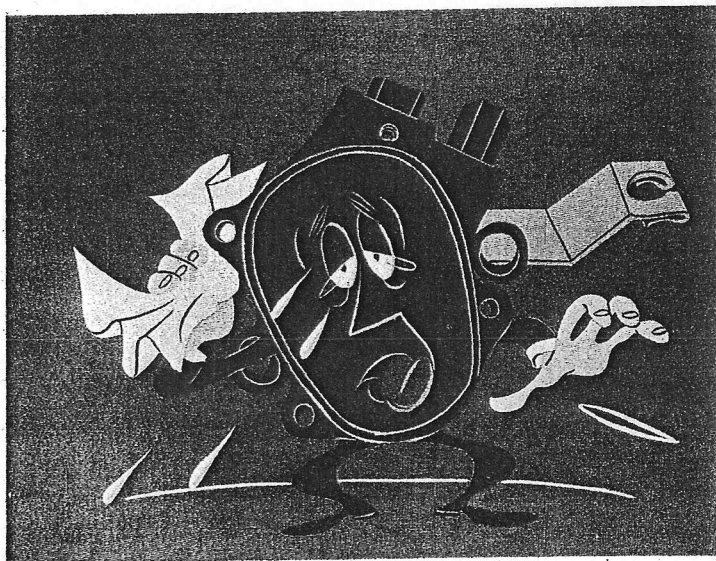
If the front leveling valve on a 1958 Cadillac becomes overheated -- which may happen when the car idles for an extended period of time -- the shaft seal is likely to develop a leak. When this happens, replace the leveling valve with a 1959 type -- Part Number 5552593 -- that has been modified to fit a 1958 car.

The shaft seal on the '59 leveling valve is not so likely to develop a leak since it is designed to withstand higher operating temperatures. However, if a leak should develop, we can simply replace the "O" ring shaft seal, since the '59 valve is completely serviceable.

Another hint on the '58 leveling valves -- the adapters may rust to the valve body, making them difficult to remove. To break the bond of rust, use a few drops of rust solvent.

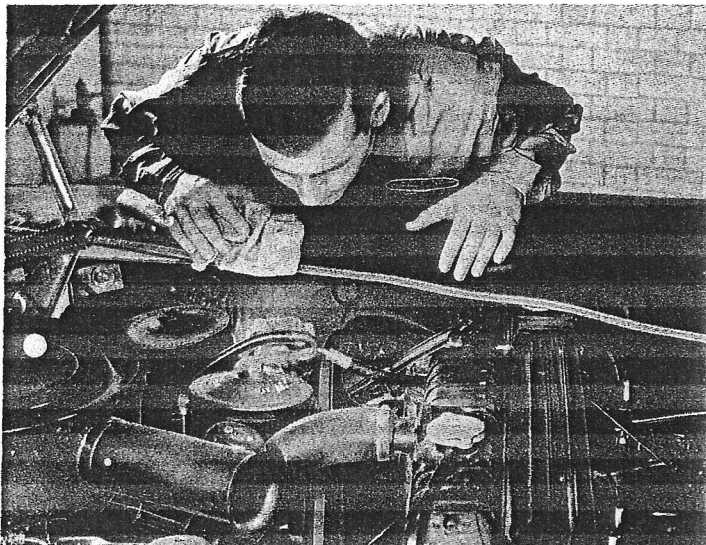
First of all, it may just be a case of an improperly adjusted compressor belt -- which we can check by using our Belt Tensioner Gage, J-6733.

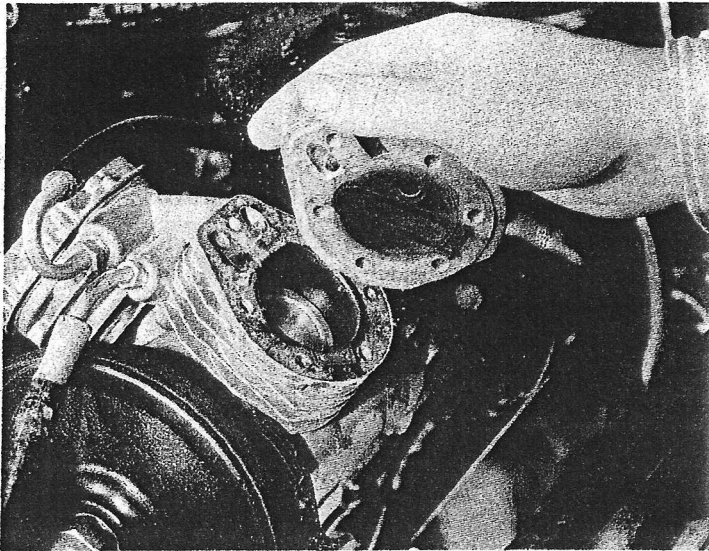
It could also be a defective compressor belt, in which case it is possible to detect a wavy motion -- that is, a side to side motion -- that can be seen if we sight along the top edge of the belt with the engine running. This wavy motion should be distinguished from the slight amount of up and down motion of the belt, which is normal and nothing to worry about.

On early 1958 cars, the single strength compressor mounting bracket may bend when the belt is tightened to the specified tension. In a case of this type, the bracket should be replaced with a double strength bracket -- Part Number 3511638 -- along with an additional rear brace -- Part Number (for the kit) 3631500. The double strength bracket was used in production in the middle of the 1958 model year after engine number 044720, and the rear brace was added in 1959 after engine number 067300. (This rear brace is also the service fix for the occasional 35 - 40 MPH vibration caused by the compressor.)

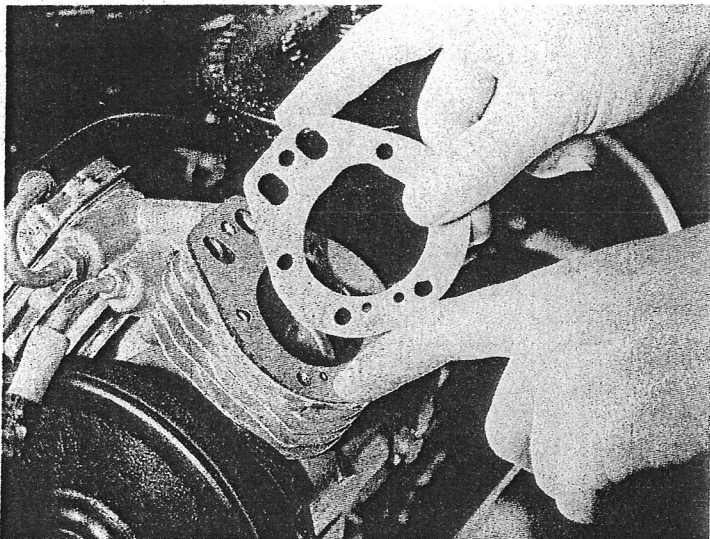
A build-up of carbon deposits on the heads of the compressor will cause the belt to stretch. The best way to test for carbon deposits is to remove the outboard head -- the one on the left hand side of the compressor -- since traces of carbon are likely to form in this cylinder first, because it operates at a higher temperature. Only a thin film of carbon will cause a substantial increase in pressure in the cylinder since the compression ratio of the compressor is so high.

Before we remove the head of the compressor we should disconnect the high pressure hose at the accumulator tank to release the pressure in the compressor. If this isn't done, the compressor head is likely to come flying off once it is tapped loose.

If carbon is allowed to build up in the compressor, it is likely to spread through the system -- causing erratic behavior of the leveling valves and the air lift valve.

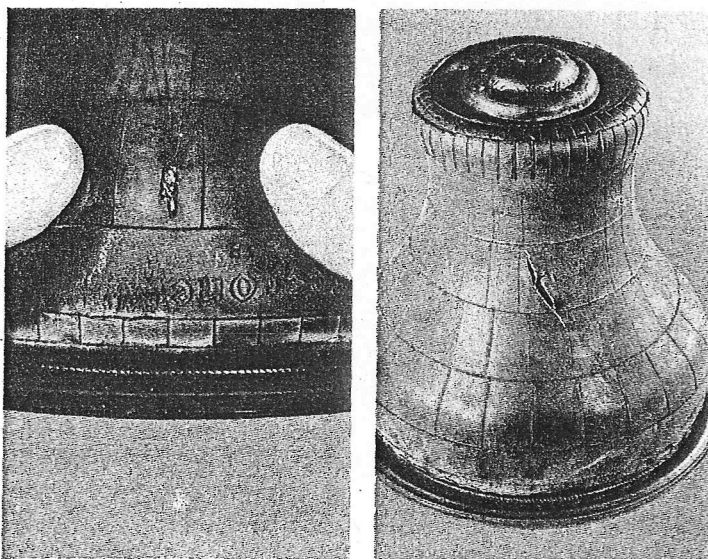
The bellows is composed of three layers -- an outer rubber skin, a layer of nylon cording, and an inner rubber skin. The outer rubber skin is merely a protective cover -- much like the paint on the body of the car, or the outer rubber casing on automobile tires. The strength of the bellows is in the nylon cording. The inner rubber skin prevents air from leaking out. Keeping this in mind, we can see why the only scorings we have to worry about . . .

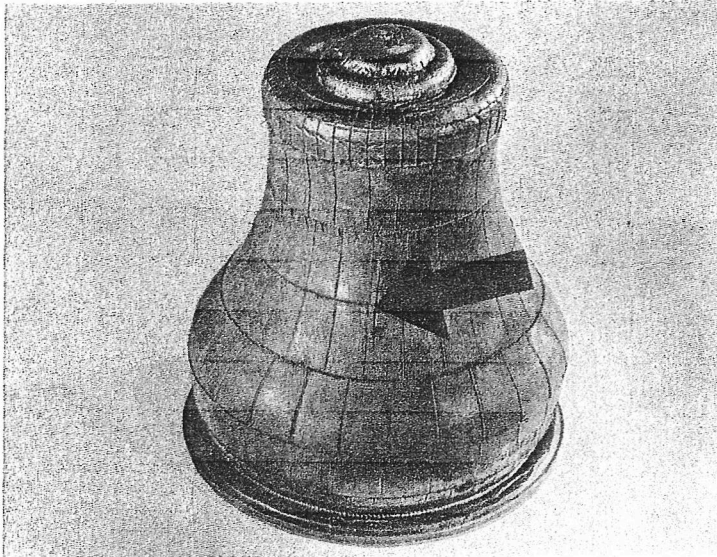
. . . are those that are deep enough to reveal the nylon cording . . .

. . . or a slit which runs parallel to the nylon cording -- since a diagonal slit of this type indicates a defect in the nylon cording, and is a strong indication that the bellows may be ready to rupture.

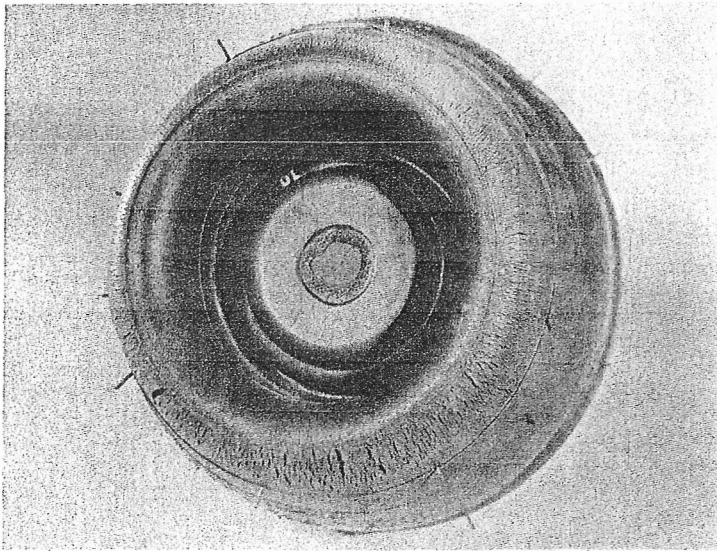
If the slit is vertical or horizontal, it is not running parallel to the cording, and -- as long as the slit is not deep enough to reveal the nylon cording -- the bellows should not be replaced.

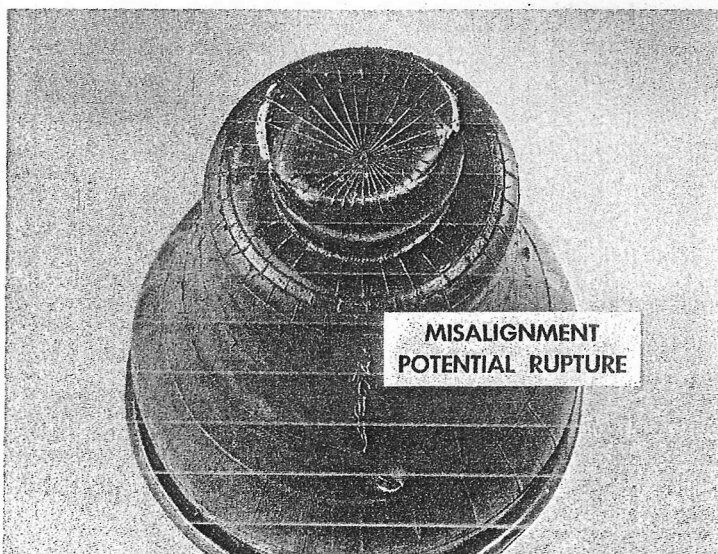
Cracks like this -- called ozone cracks -- are also all right, as long as they do not reveal the nylon cording. You've probably seen cracks like this on the side wall of tires. Just as tires are not weakened by these cracks, neither are the bellows. Ozone, by the way, is a form of oxygen, and is formed by a discharge of electricity in the air. It's also important to check the bellows for correct alignment and positioning.

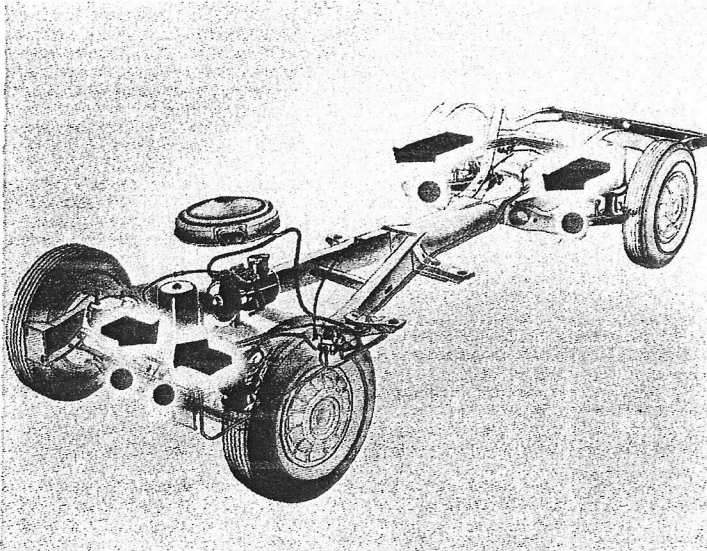
If the bellows is not properly aligned, it will not sit squarely on the piston, and the bellows may become kinked and eventually rupture. On the illustration to the left, you can see where the bellows was mispositioned on the piston.

The positioning of the rear air domes is greatly affected by the alignment of the rear center upper control yoke. Be sure to check the positioning of the rear domes after any service work is performed on the yoke of a car equipped with Air Suspension.

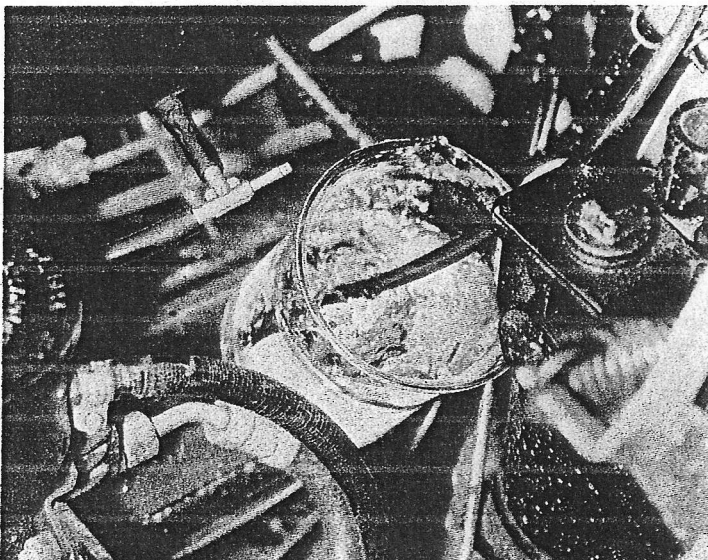
The rubber seal in the hex plunger on the 1958 lift valve is dependent on the travel of the bowden cable for positive sealing against air leaks. Such an air leak will cause air to escape from the exhaust hose at the "tee" fitting on the air cleaner.

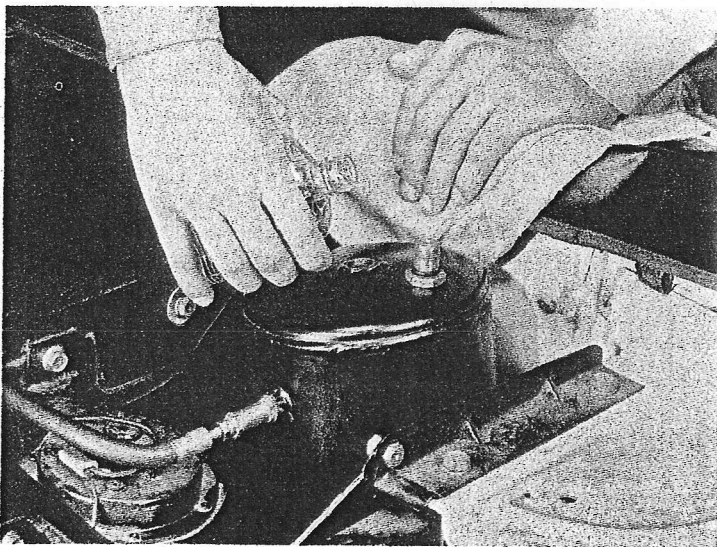
Draining the accumulator tank of water is an extremely important item when it comes to Air Suspension preventive maintenance. In a period of one month as much as one quart of water may have accumulated. That's why, just in case an owner has gone somewhere else for his lubrication, it's a good practice to drain the accumulator tank every time a car equipped with Air Suspension comes into our shop. Also, if the temperature gets down around the freezing point, we should add 1/2 pint of Methyl (wood) alcohol to the accumulator tank every time it is drained.

If water is allowed to remain in the accumulator tank, rust will form on the interior of the tank. After a while, rust flakes will break away and spread through the system neatly lodging themselves in every valve and orifice they can find. When this happens, we have to clean the entire Air Suspension system, and may even have to replace the accumulator tank.

There are two types of Air Suspension preventive maintenance we should concern ourselves with. The first is the maintenance we give every time the owner comes in for lubrication -- draining the accumulator tank, adding wood alcohol to the accumulator if needed, and checking the condition, position and alignment of the bellows. The second preventive maintenance is a relatively new recommendation, and very important -- a yearly Air Suspension check-up . . . a thorough going over of the entire system.

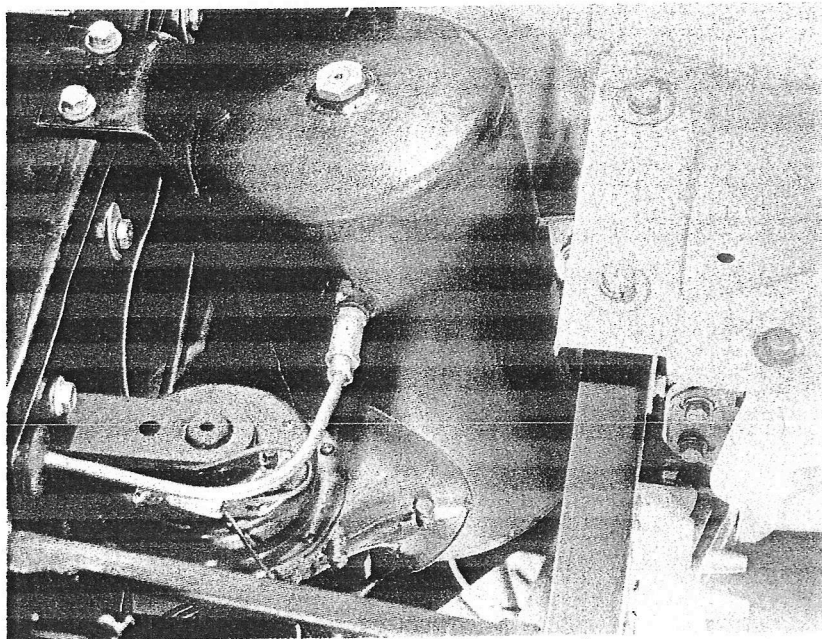
And a good place to begin the yearly check-up is at the beginning of the Air Suspension system -- the air compressor. We should:

- Check belt tension
- Check for oil leaks at the crankshaft oil seal, sump cover plate, and at the connection between the compressor and the power steering pump on 1958 cars.

- On 1958 compressors, check the pump pressure at the test plug. The minimum lube pressure should be 6 psi at slow engine idle, and 16 psi at 1000 engine RPM. If the pressure is above these specifications, there is nothing to worry about. However, if the pressure is low, clean the pump and oil inlet filter screen.
- Inspect for carbon build-up by removing the cylinder heads. When installing the heads, use a new head gasket, and properly tighten the cylinder head bolts.

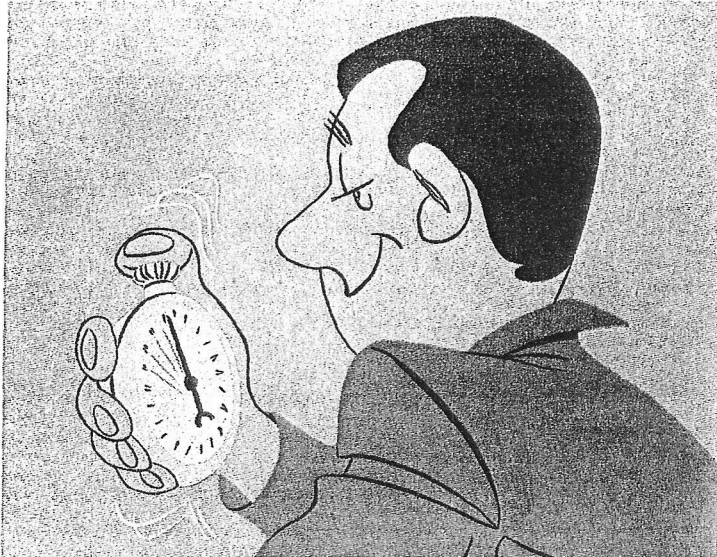
- Check the standing height of the car, following the procedure given in the Shop Manual.
- Road test the car to make sure its riding quality is up to par.

- Time how long it takes for the car to reach its lift position -- and how long it takes to get back down again. The car should take no longer than one minute going up, and five to seven minutes on its way down -- providing that the accumulator tank is up to pressure (at least 110 pounds) before you start.
- Check for internal leaks of the lift valve by disconnecting the exhaust hose at the "tee" fitting on the air cleaner and placing the end of the hose in a container of water, as was previously explained.
- When it comes to checking for leaks, a strong solution of leak detector fluid (or soap and water) -- applied to the leak test points indicated in the Shop Manual -- will detect most leaks.

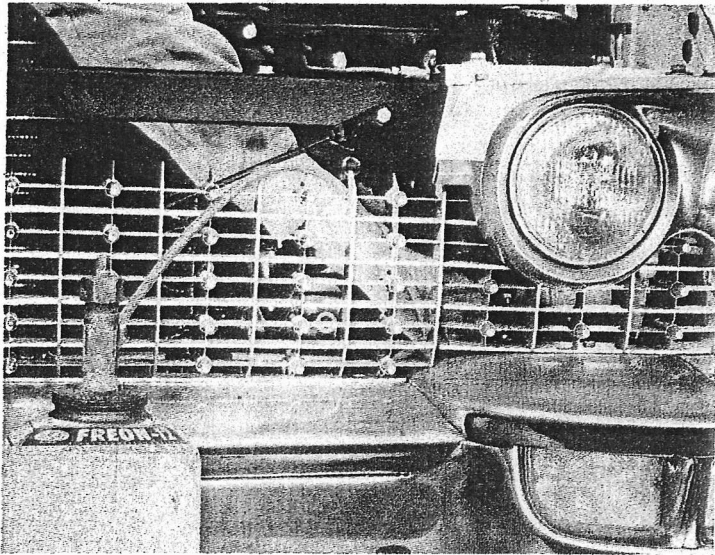
However, if the leak is hidden way in there, where it's rather hard to find, charging the system with Freon-12 vapor is probably the best way to find it. A couple of words of caution however, when we employ this method of leak detection.

- First, we should always protect our eyes with a pair of goggles when we're working around Freon-12.
- Second, Freon can damage the Air Suspension system if it's left in the system too long. For this reason we can use the Freon vapor test method, only if we purge the system as soon as we've completed the test, and providing we use just the right amount of Freon-12 vapor when charging the system.

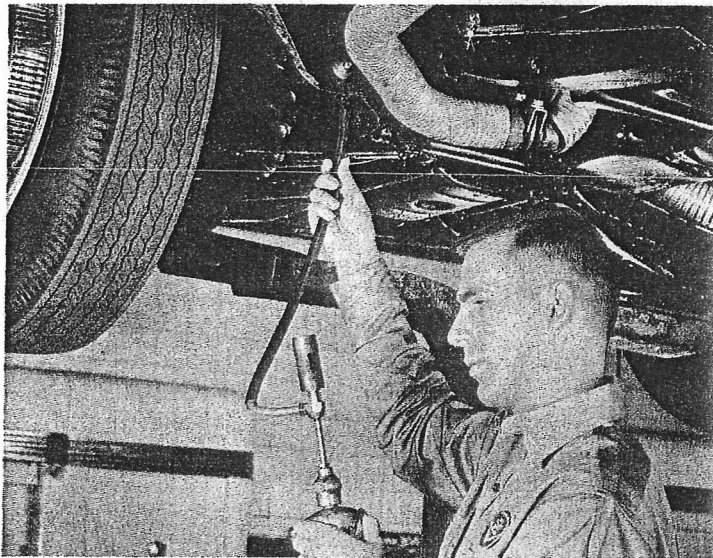
The correct amount of vapor will enter the system if we first purge the air from the accumulator tank, and then charge the accumulator tank with Freon-12 vapor, using the special adapter that will fit the accumulator service valve, Tool Number J-8731. We should charge the system until it reaches drum pressure, at which point you can no longer hear the hissing sound of the Freon vapor entering the accumulator tank. Disconnect the Freon drum.

Do not attempt to charge the system with the Air Conditioning Charging Station, since it is designed to give off Freon liquid, rather than Freon vapor -- which would prove rather devastating to the Air Suspension system.

To get the Freon vapor out of the accumulator tank, and circulating around the system, pull out the air lift handle and let the car reach its full lift position. Then let the engine run for a few minutes.

Once we have the Freon vapor circulated throughout the system, we can get the car up on a hoist, and check for leaks. A leak is indicated when the flame in the head of the torch type detector, Tool Number J-6084, changes color. A green flame indicates a small leak; blue a medium leak; and purple a king-size leak. A good way to find out how to use a torch type detector if you're not familiar with it, is to contact your own Air Conditioning man -- and, of course, refer to your Shop Manual.

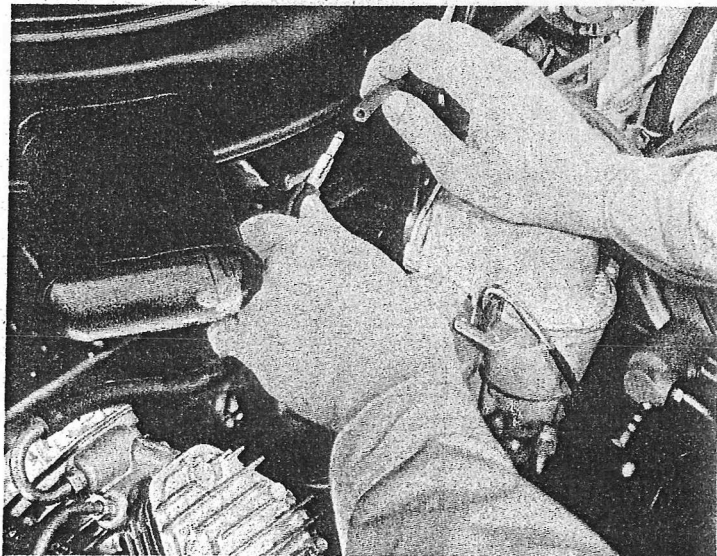
As we stated before, it's essential that the Freon vapor be purged from the system as soon as we have completed checking for leaks. To do this, we should first purge the accumulator tank by depressing the service valve until the hissing has stopped, and then remove the service valve. Do this with the air lift handle still in out position. When the air is completely exhausted from the system, replace the service valve, and replenish the air supply by running the engine.

When the car has again reached its lift position, disconnect the air return line at the "tee" fitting on the air cleaner (to avoid recirculating traces of Freon vapor) . . . push in the air lift handle . . . and let the car settle to its normal height.
