Cadillac **SERVICE ROUND TABLE**

SERVICE SUMMARY

**THE GRAY LIGHT
OF DAWN**

... a discussion of "booms" and vibrations

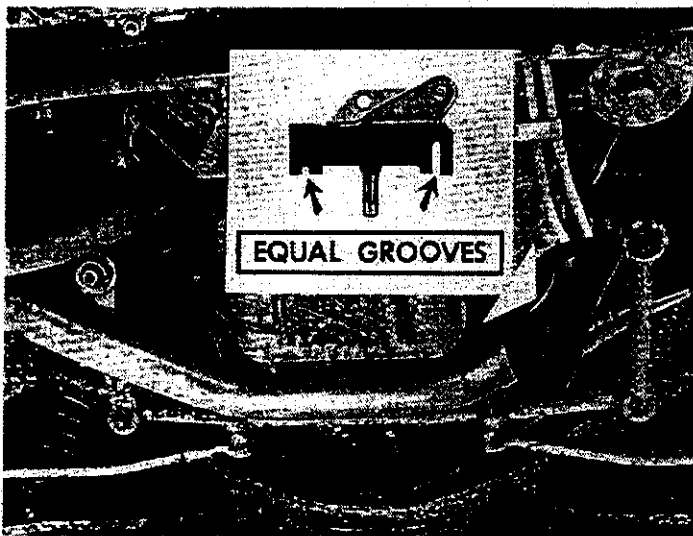
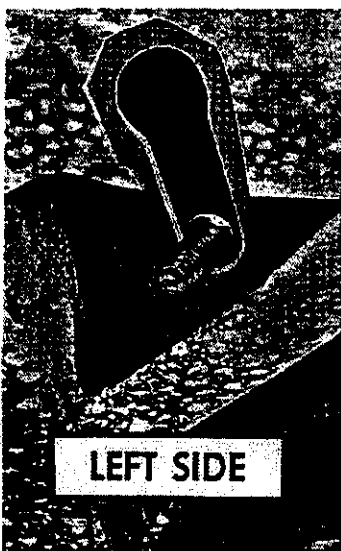
2. Check the Alignment of the Engine

A visual check of the front mounts will determine if the engine is leaning far enough to the left so the right hand mount is not distorted. The flange of the right hand mount should be centered around the rubber portion, so the upper and lower grooves are of equal width. This indicates there is no strain on the right hand mount. However, if the upper groove is closed up, the engine should be repositioned.

To reposition the engine, the nuts and washers should be removed from the front mount studs, and the engine shifted so the left hand mount is at the bottom of its slot, but the right hand stud a little ways up (just enough so the stud does not touch the bottom of the slot). It may be necessary to place one or two body shims between the right hand mount and the frame, to lift the right hand stud off the bottom of its slot. With the studs positioned correctly in their slots, the engine is leaning enough to the left to compensate for the torque, and is at the correct height. The nuts and washers can now be installed, and the nuts torqued down to 90 foot-pounds.

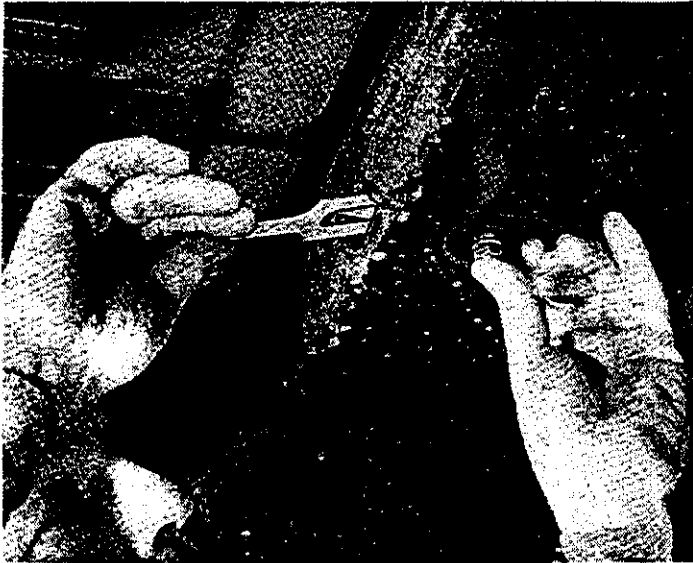
5. Custom Align Prop Shaft as Required

Once we have aligned the prop shaft using the special gage set, we are ready to customize this alignment to the standing height of the particular car we are working on. To do this, refer to the chart on page 7-13 of the 1962 Shop Manual, and determine what shims need to be changed in order to customize the vertical alignment. Once these shims have been changed, of course, the alignment will no longer match-up to the measurements made by the alignment gages. In fact, the alignment gages can actually be removed before customizing the vertical alignment, since we have no further use for them. After customizing, the prop shaft is in proper alignment for the smoothest possible operation with a three passenger load.

This alignment is usually satisfactory with the driver alone, or with a six passenger load. However, if the owner drives alone most of the time, and he wants the best possible alignment for that condition, we can further customize the alignment by removing a 1/16 inch shim from under the prop shaft center bearing mount . . . or, if you are all out of shims at this point, by adding a 3/64 inch washer under each of the two legs of the rear motor mount. On the other hand, the owner may want the best possible alignment for a six passenger load (or possibly his trunk is always heavily loaded). This would be quite rare, however, since the ride with only one passenger would be less than desirable. However, if this is the case, an extra 1/16 inch shim can be added under the center bearing mount.
